CARLIN • SIMPSON & ASSOCIATES

Re: Report on Preliminary Geotechnical Evaluation for
Existing Retaining Wall #1
Scott & Elizabeth Pierpoint
2 Thistle Lane
Rye, NY (CSA Job #14-179)

EXISTING RETAINING WALL EVALUATION
PROPERTY # 1
2 THISTLE LANE
RYE, NEW YORK

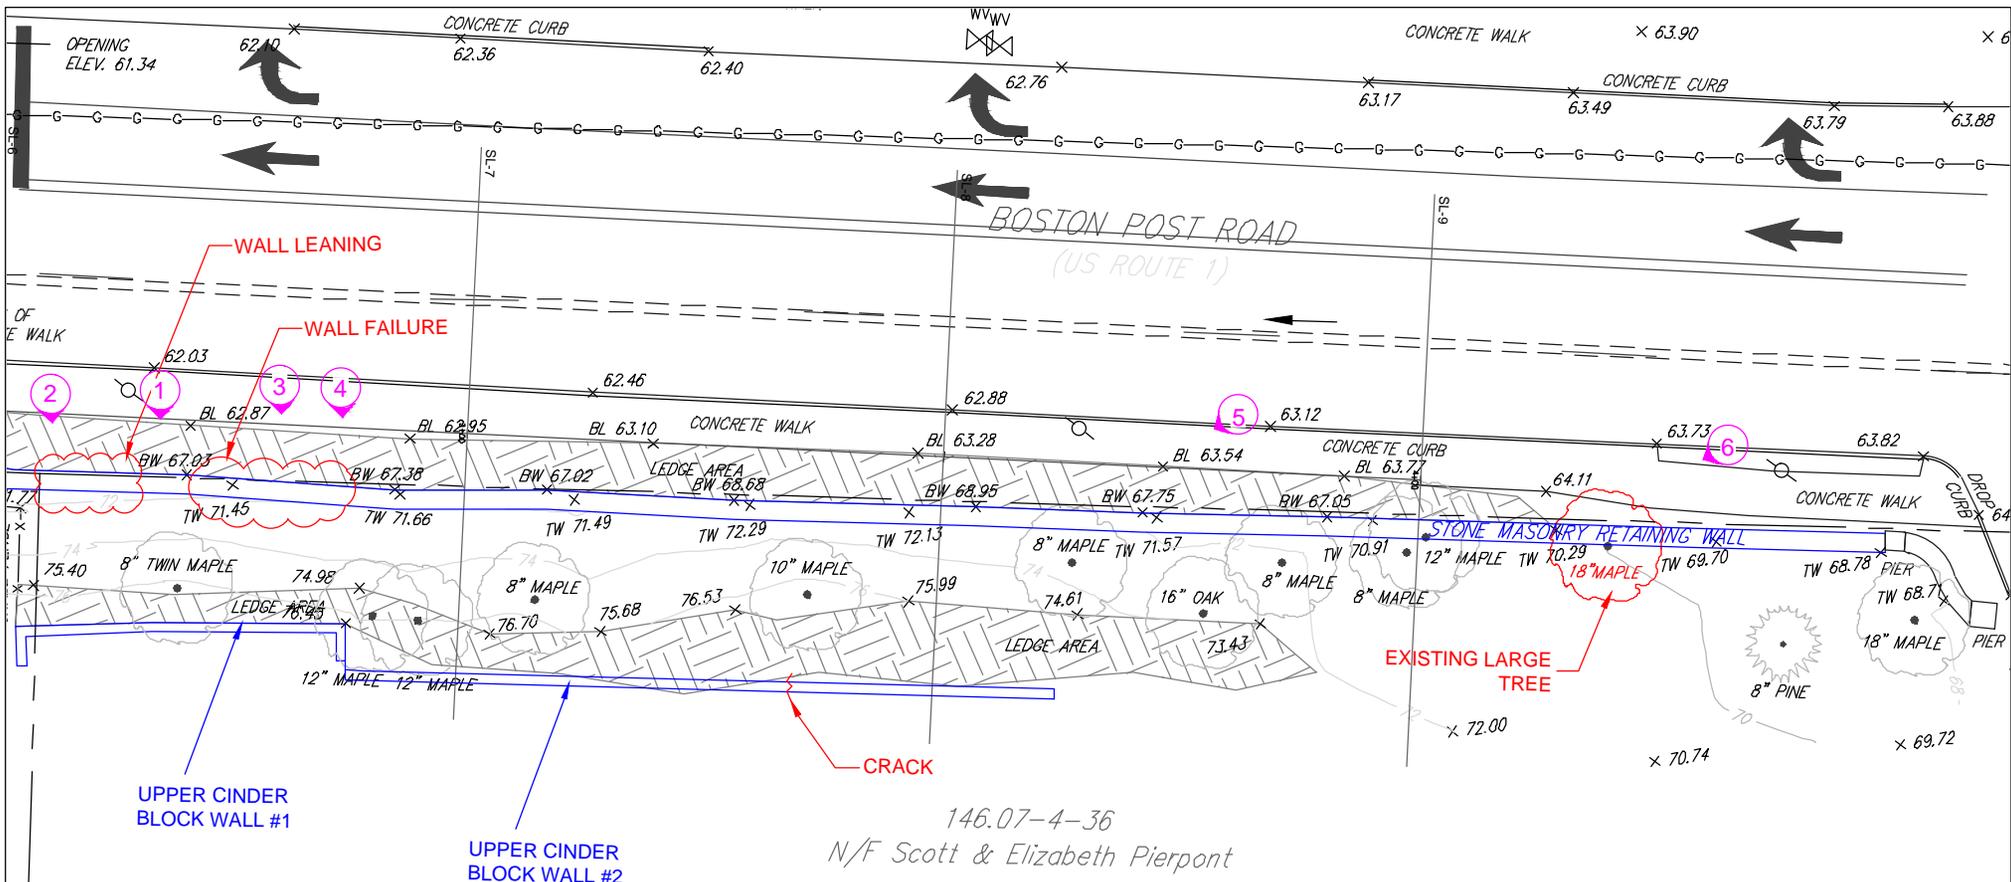
EXISTING RETAINING WALL LAYOUT

- On this property there are 3 walls. The wall at the base of the slope consists of a rock wall resting on an undulating bedrock surface. The wall height ranges from 3 to 5 feet in height.

- Above the stone wall are 2 cinder block walls approximately 4 to 6 feet in height. Refer to the attached drawing.
- Upper cinder block wall #1 is approximately 34 feet in length and shows visible signs of distress. (i.e. joints have opened up and the wall appears to be leaning).

- Cinder block wall #2 is approximately 75 feet in length and also shows signs of distress.
- The lower rock wall is approximately 193 feet in length. The first 23 feet of wall starting at the western property line is in distress. Portions of the rock wall are leaning and a section of the rock wall has failed by toppling over.

- Several large trees exist in close proximity of the rock wall.
- The eastern 100 feet of wall appears to be in fair to good condition with no visible signs of distress.

The western portion of this wall is failing and will need to be replaced. We recommend that an Engineer registered in the state of New York be retained to evaluate the 3 walls and to prepare a design for 3 new walls or a design to repair the 3 walls.

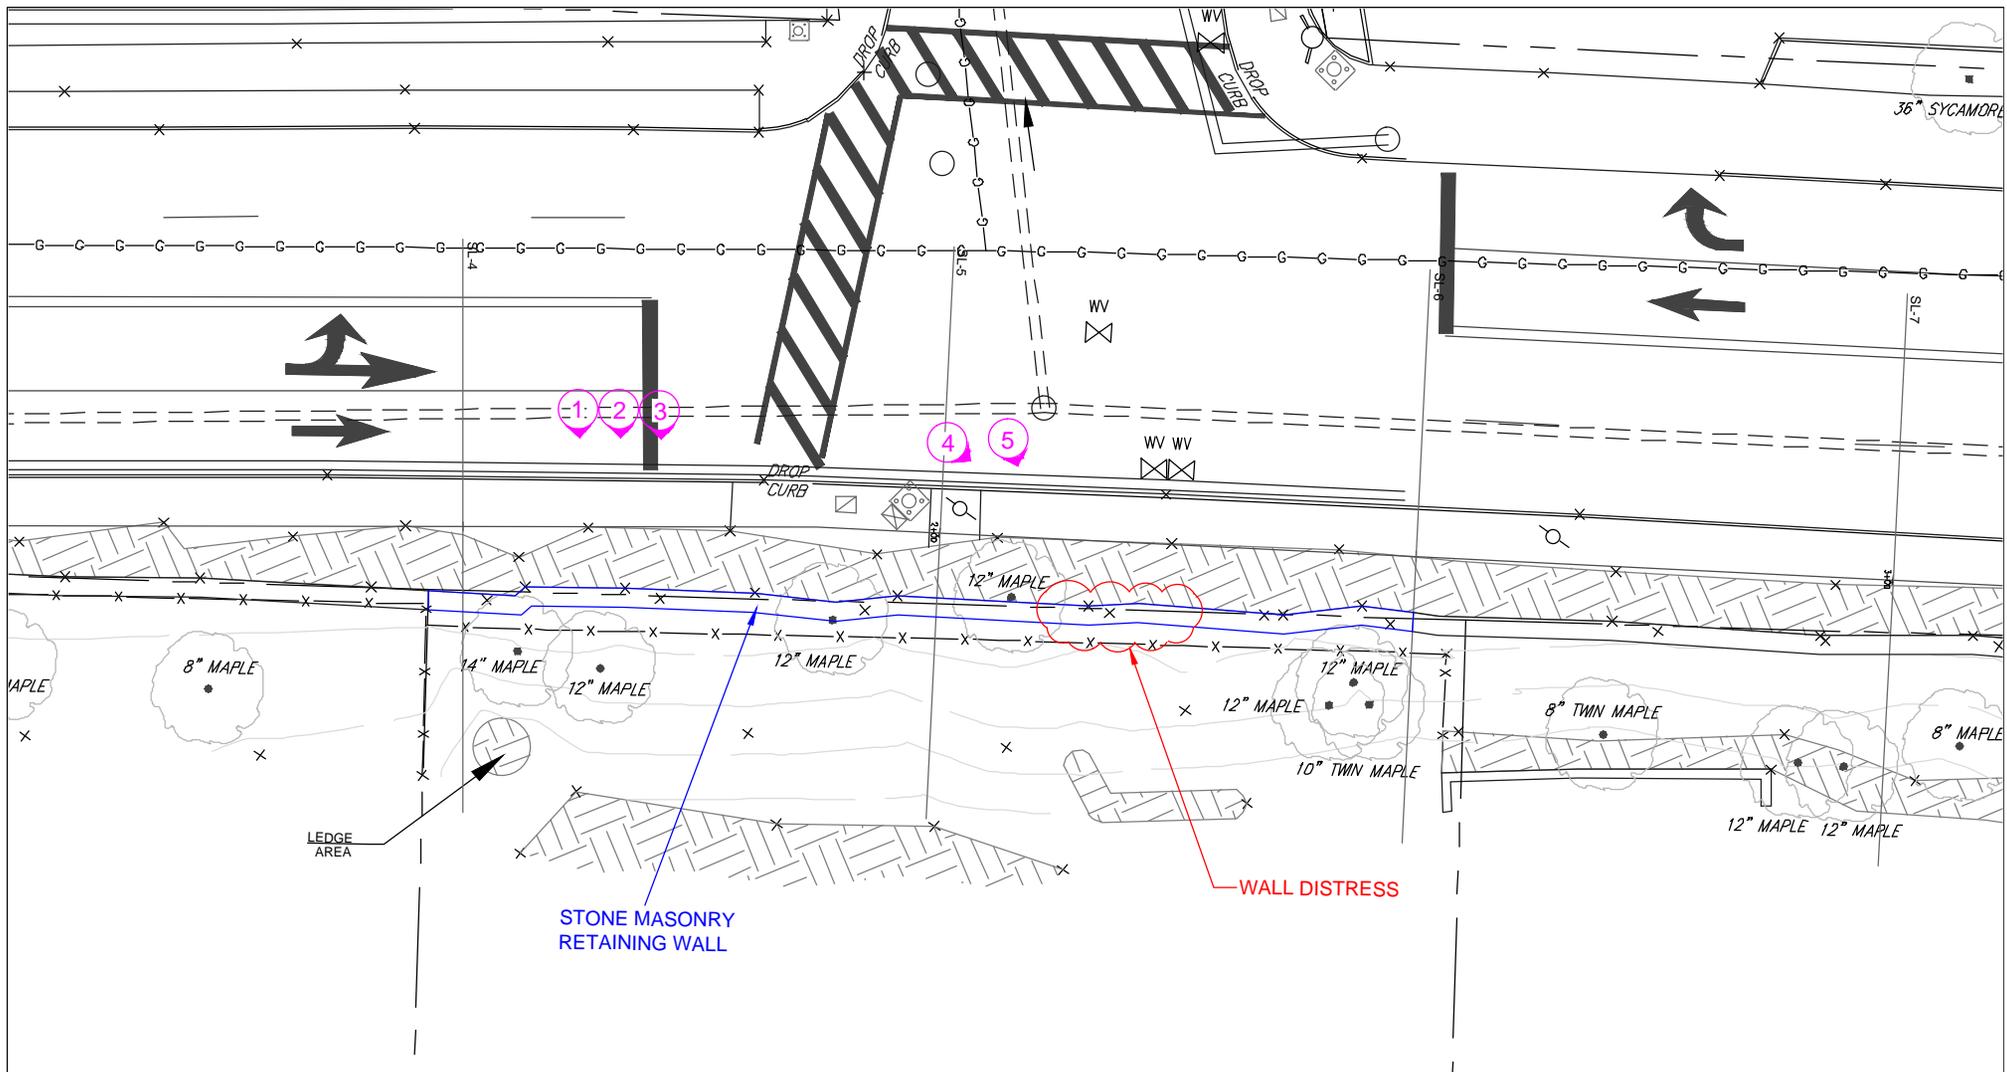
EXISTING RETAINING WALL LAYOUT

- The wall ranges in height from 3 to 4.5 feet and rests on top of an undulating bedrock surface.
The combined height of the bedrock slope and rock wall is approximately 5 to 6 feet.
- The rock wall consists of large and small rock blocks predominantly dry laid (i.e. no mortar in the joints).
- Sections of the wall are in distress and are leaning outward.
- A section of the wall has failed by toppling over refer to photos #4 & 5.
- 5 large trees are in close proximity to the top of the wall.
- In general, the wall is in poor to very poor condition. Additional sections will likely fail in the near future resulting in rock blocks rolling down the base of the rock wall and exposed bedrock.

These factors of safety are low and consistent with the poor condition of the wall. In our opinion, the possibility of a wall failure is moderate to high. A failure will likely consist of blocks falling from the wall and a possible toppling of the wall.

WALL DISTRESS

We recommend that an Engineer registered in the state of New York be retained to evaluate this wall and to prepare a design for a new wall or a design to repair the existing wall.

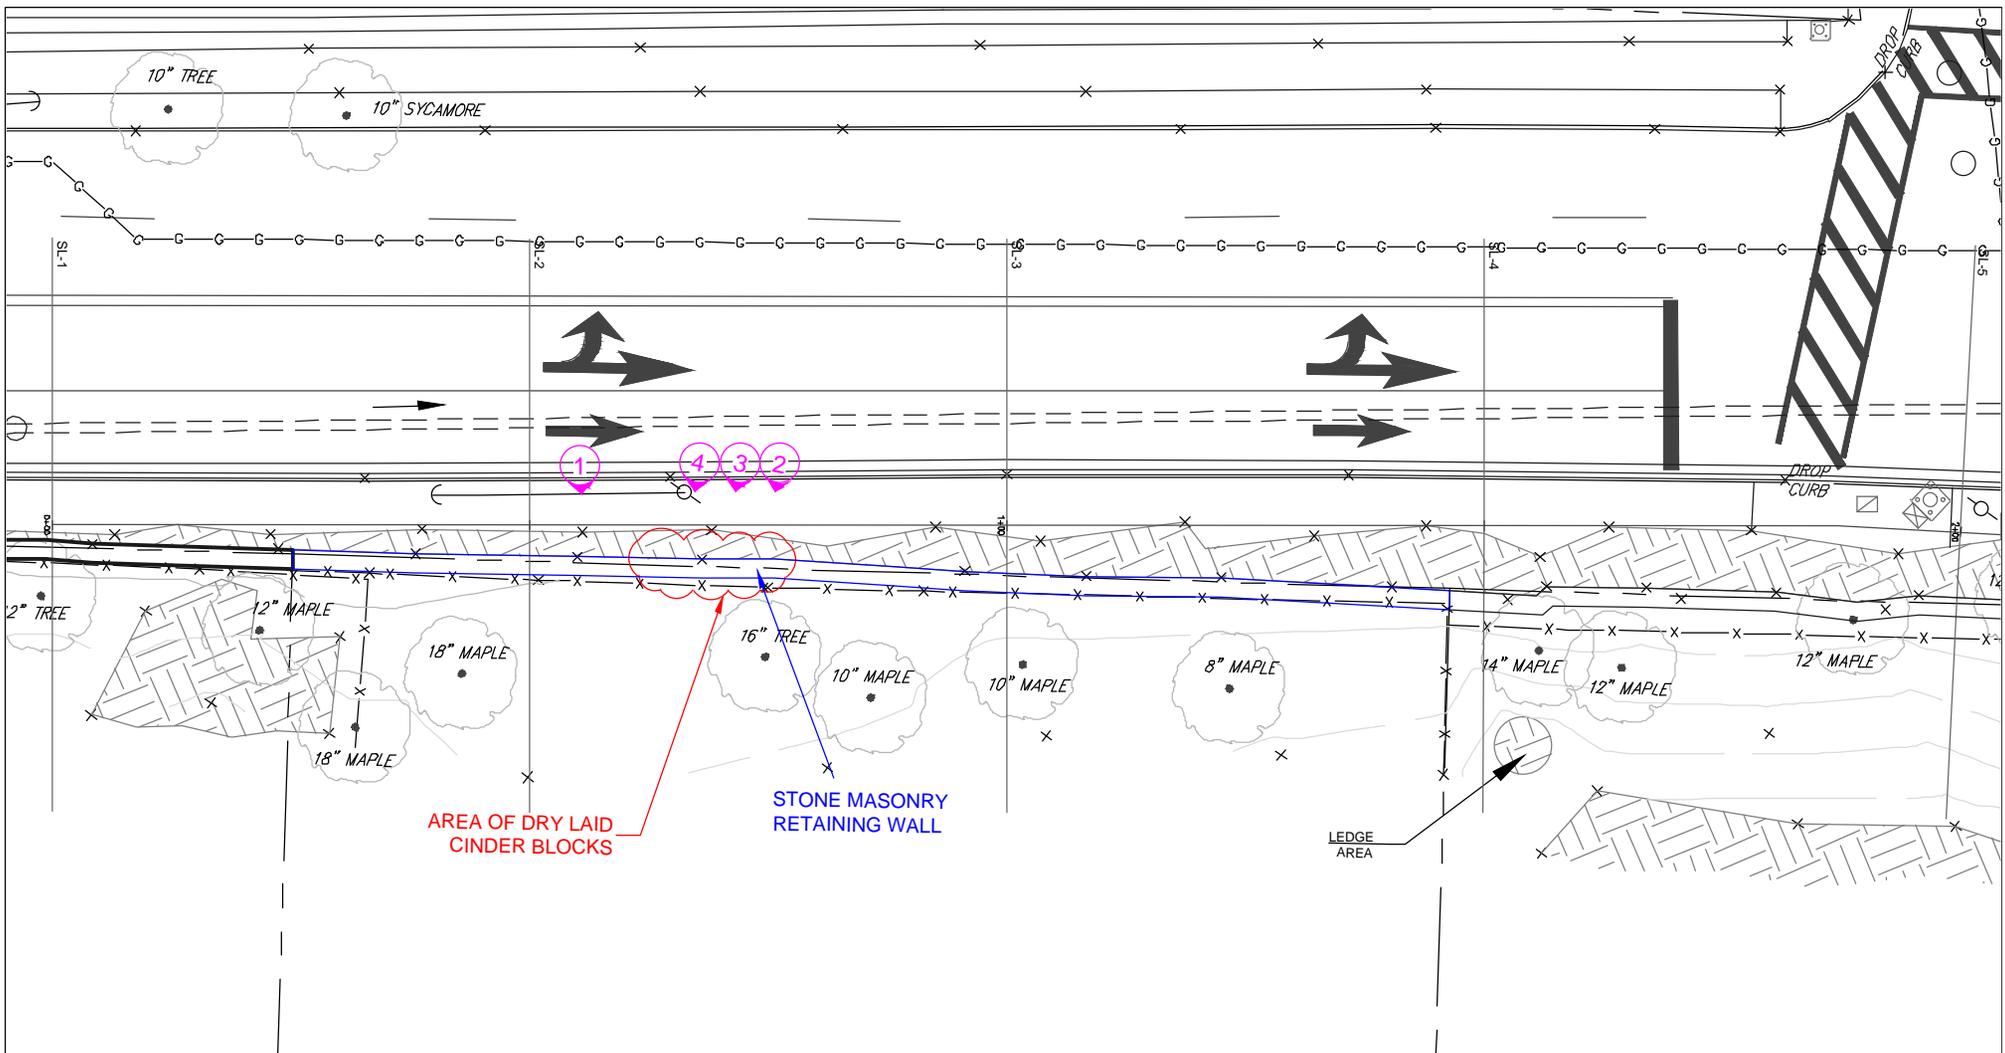
EXISTING RETAINING WALL LAYOUT

- The wall ranges in height from 2 to 6 feet.
- The wall consists of large and small rock blocks with pieces of mortar the rock block joints.
- It appears that sections of this wall have been re-built and the top of the wall has been extended or re-built with dry laid flat cinder blocks. (See photos 2, 3 & 4).
- The integrity of the wall varies where some areas appear stable while other areas show spalling rock blocks.
- This entire section above the wall is heavily vegetated and the wall was placed on an undulating bedrock outcrop.
- The width of the wall is unknown, however we estimate the thickness to be 2 to 3 feet.
- In general, the wall appears to be in poor condition with visible signs of distress.

These factors of safety are low. In our opinion, the possibility of a wall failure is low to moderate. A failure will likely consist of blocks falling from the wall and a possible toppling of the wall.

AREA OF DRY LAID CINDER BLOCKS

We recommend that an Engineer registered in the state of New York be retained to retained to evaluate this wall and to prepare a design for a new wall or a design to repair the existing wall.

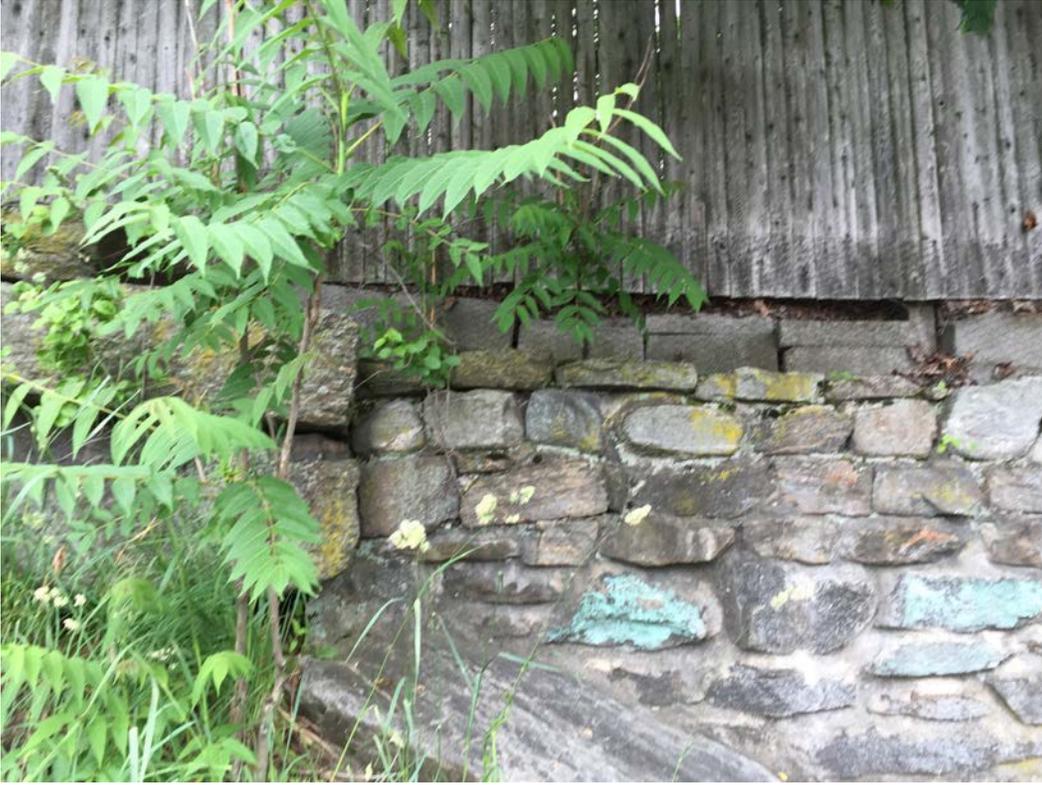
Photo No. 2

In our professional opinion, portions of this wall are failing (specifically in the area of photos # 2 ,3 & 4) and the wall will need to be replaced or repaired.

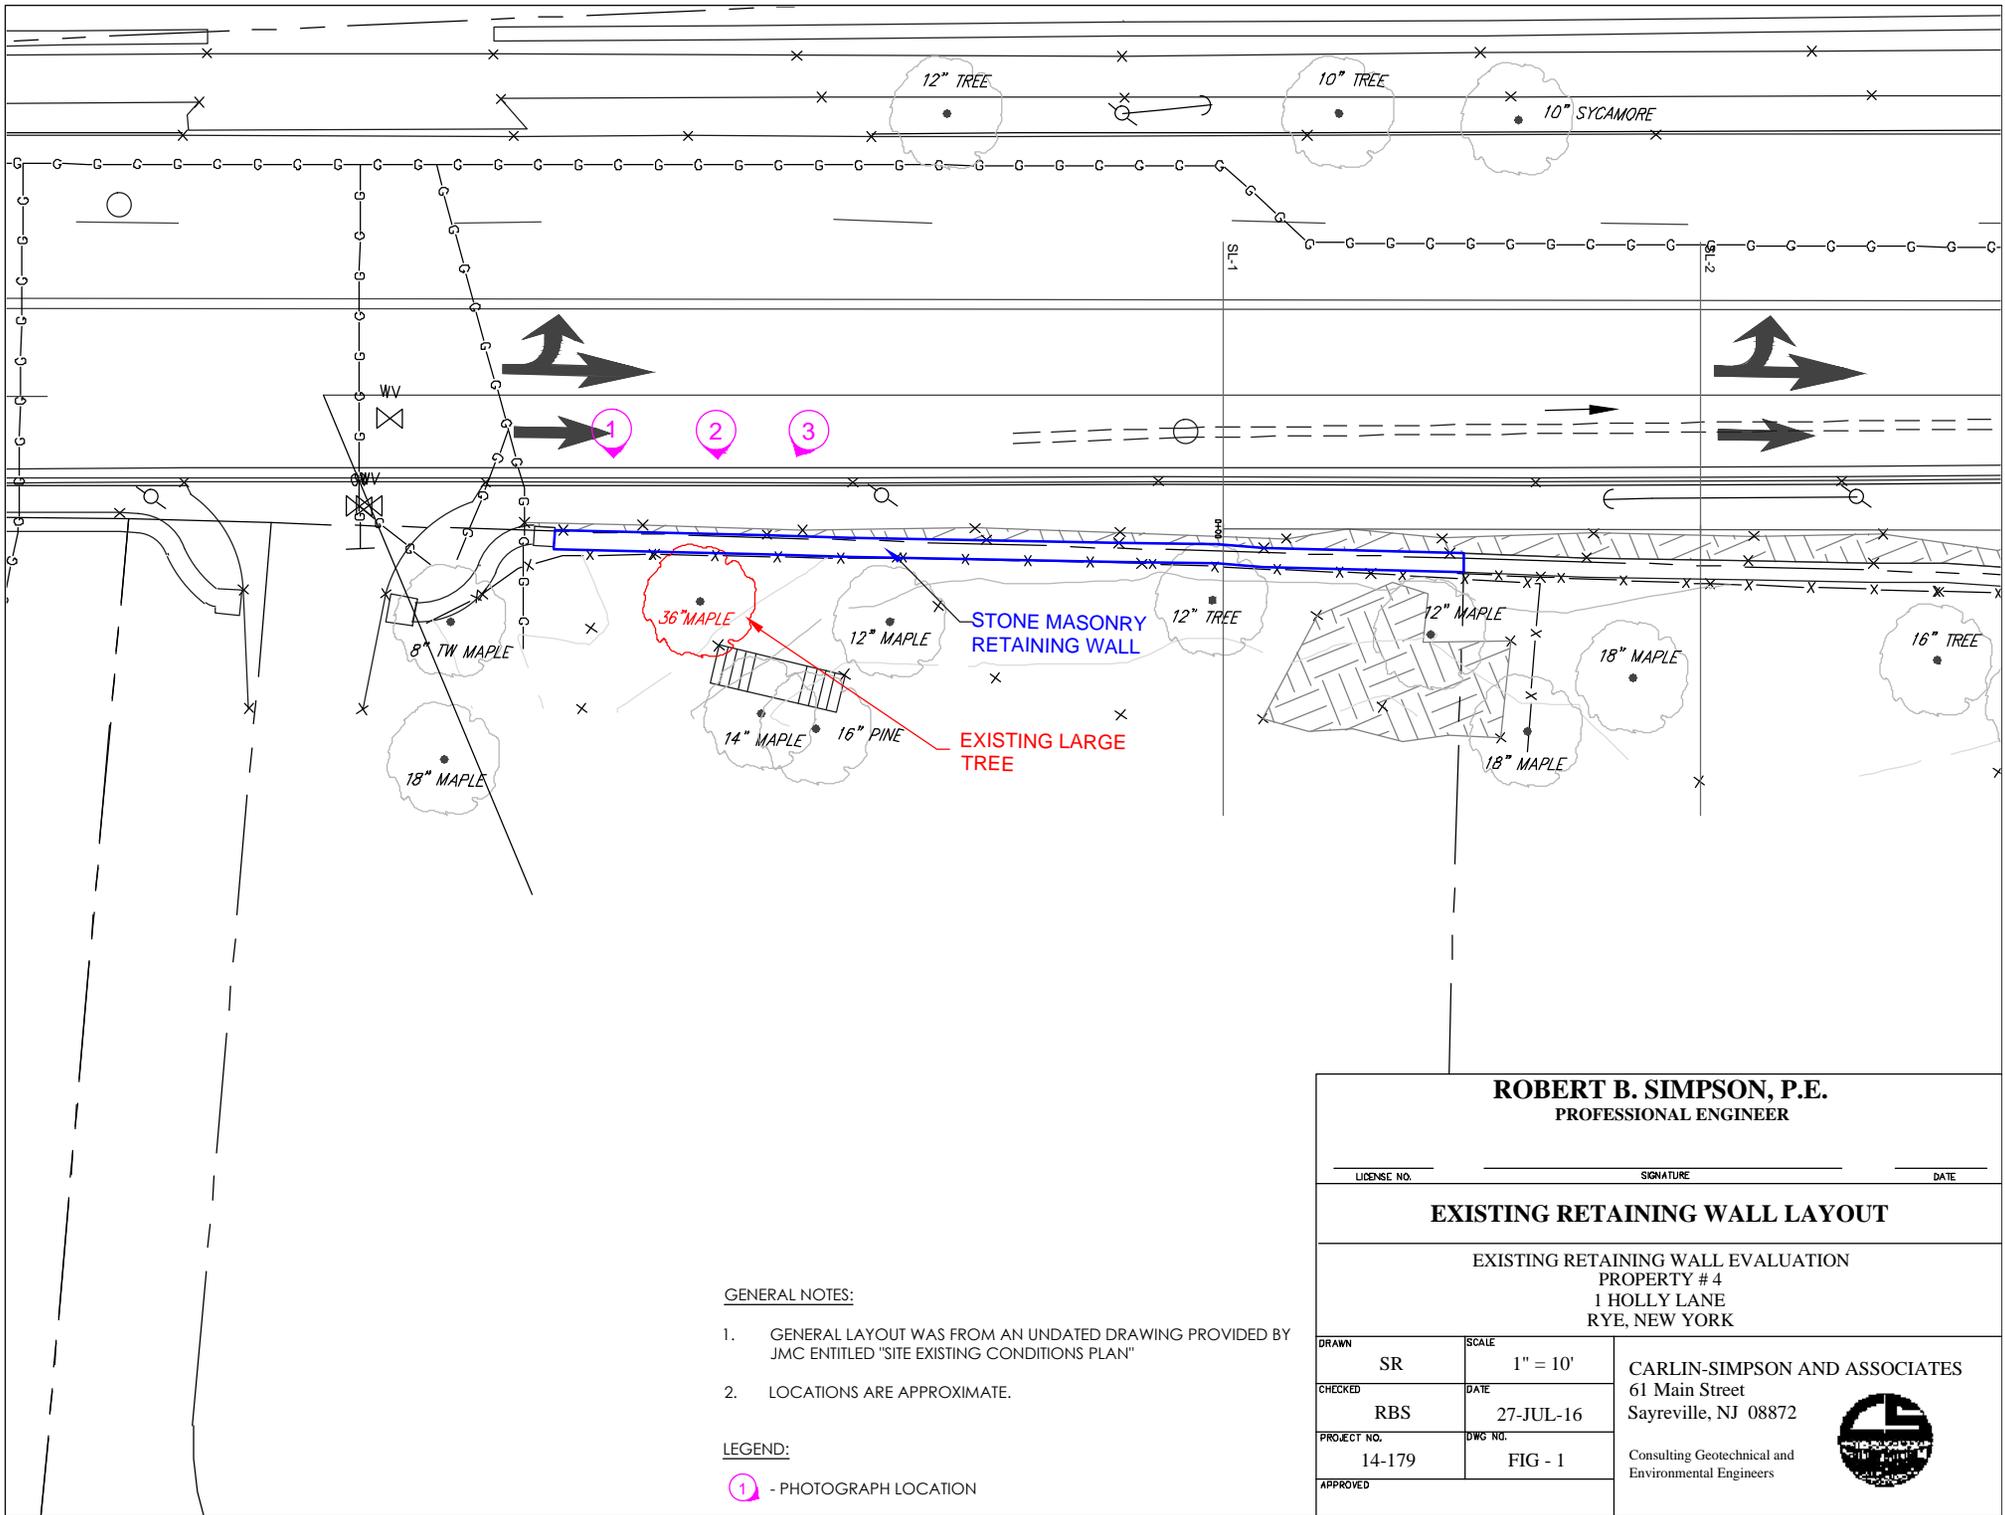
EXISTING RETAINING WALL LAYOUT

- The wall ranges in height from 4 to 6 feet.
- The wall consists of large and small pieces of rock with mortar in the joints.
- The top of the wall consists of flat capping stones.
- The estimated wall thickness is 2'6" to 3'6".
- In general, the wall appears to be in fair to good condition.
- We did not observe any areas of distress in the wall.
- A large tree is located near the top of the wall. (Location shown on the attached plan).

These factors of safety are above the accepted factors of safety and the condition of the wall is fairly good with no visible sign of distress.

In our opinion, the possibility of a wall failure in this area is low. We recommend that an Engineer registered in the state of New York be retained to verify the actual wall dimensions, retained soil parameters and the factors of safety for the existing wall.
