PUBLIC SAFETY & COURT FACILITIES STUDY

April 12, 1999

KAESTLE BOOS ASSOCIATES, INC.

*Public Safety and Court Facilities Study
for the
City of Rye
Rye, New York
KB# 97075*

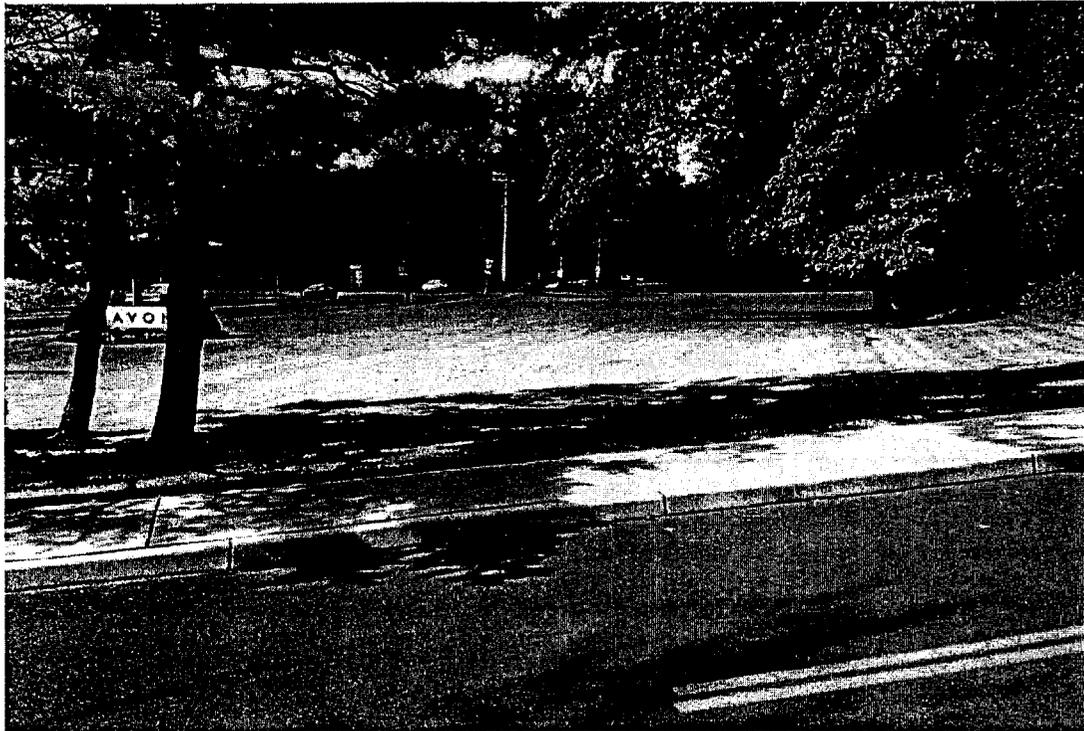
Off Peck Avenue, at corner with Midland Avenue.

- ◆ The site is generally open with approximately 100' lot depth before wooded slope up to the current Avon Facility.
- ◆ There is an approximate 35 car parking facility to the north of the entrance drive to the Avon Facility.
- ◆ Access onto Midland and Peck Avenues as well as the Interstate is favorable.
- ◆ Bus service is available on Midland Avenue.
- ◆ The intersection of Midland and Peck Avenues is subject to flooding.
- ◆ Prime concern is the size and proportion of the lot-wooded slope, effectively making the site very linear and insufficient in size.

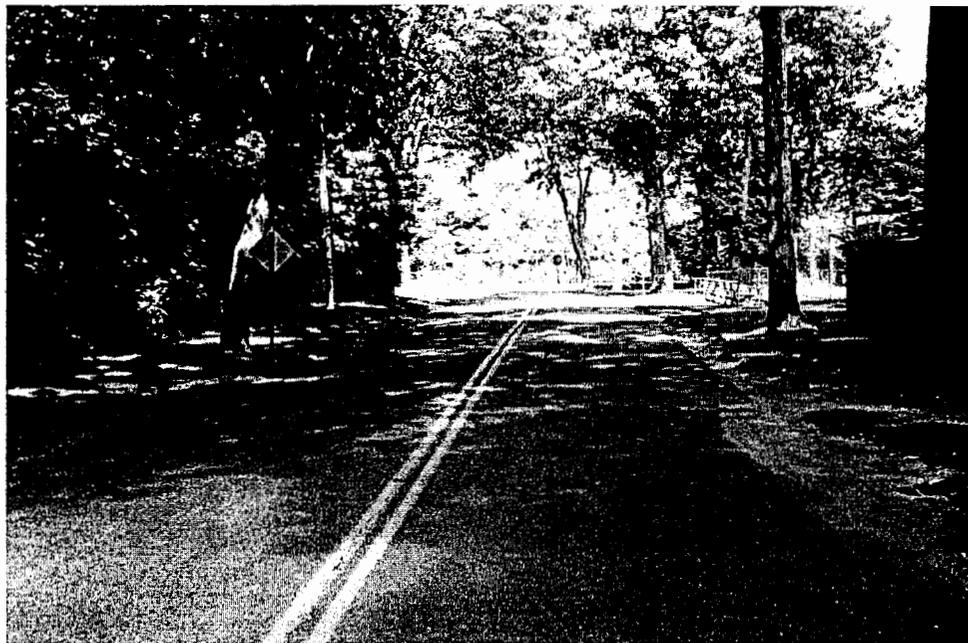
Oakland Beach Avenue

- ◆ This is one of the larger parcels under consideration.
- ◆ This parcel is set back from Oakland Beach Avenue, inside Disbrow Park.
- ◆ The site is an underdeveloped wooded knoll, with parking, circulation, Public Works, and recreation uses surrounding it.
- ◆ Initially, the parcel appears quite feasible for construction of a new Public Safety Facility. It is recommended that overall circulation studies and analyses of the entire park/Public Works complex be undertaken.

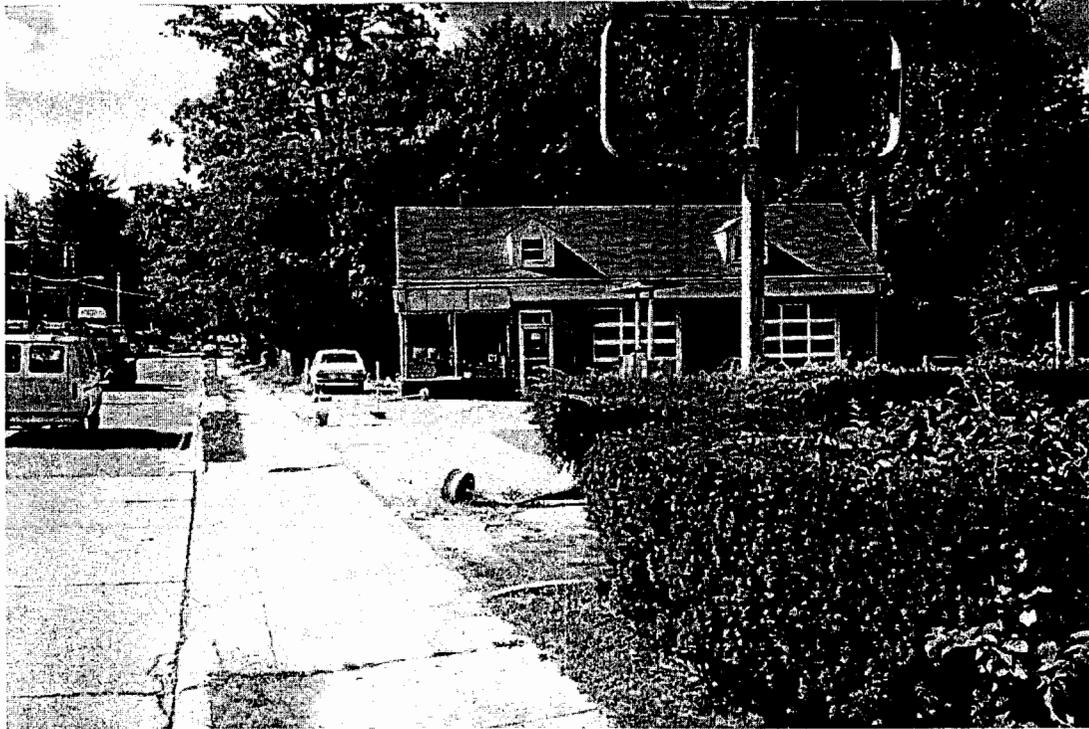
Purchase Street and Wappanocca Avenue.

- ◆ The site is too small to support the proposed facility, even with the possible addition of the adjacent property under current ownership.
- ◆ The intersection contains two signals.
- ◆ The site is located at the extreme northern point of the City.

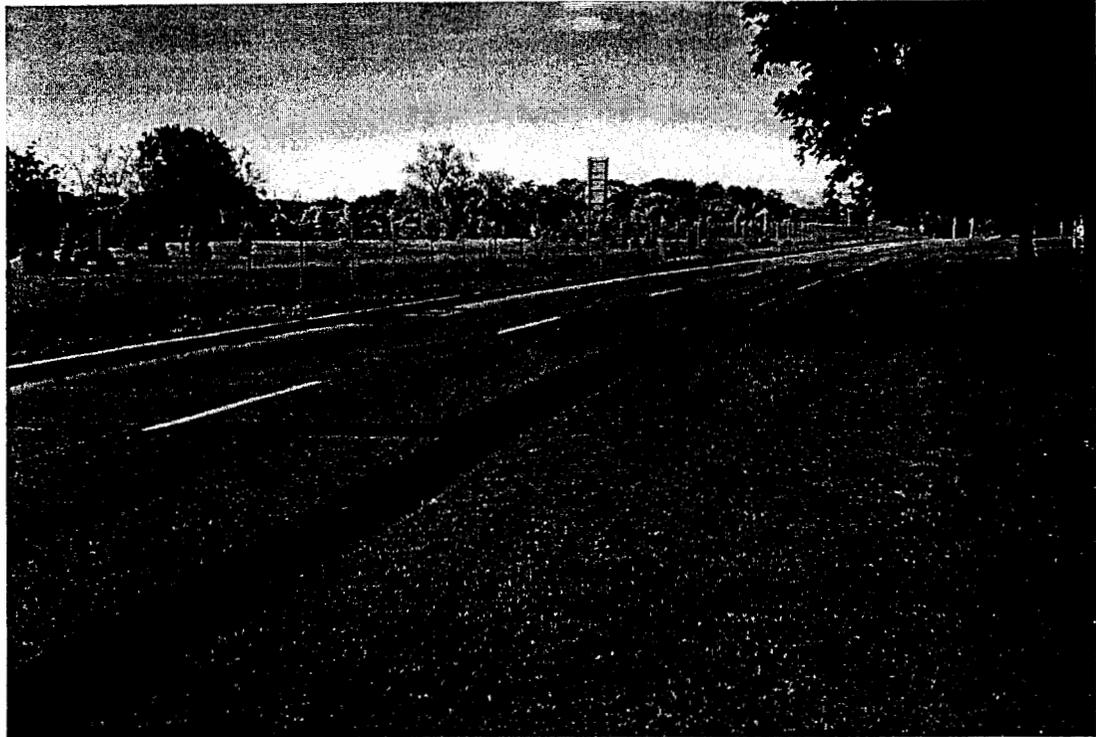
Opposite Rye Country Day School.

- ◆ The site is located where the Interchange was previously located, and is owned by the Thruway Authority.
- ◆ Site acreage is sufficient for the proposed facility, and is located on a main artery to downtown.
- ◆ The boulevard median is approximately 40' wide, allowing secure positioning of vehicles during left turn/exit movements.
- ◆ Sightlines in both directions are adequate.
- ◆ The elevations of the site determine that it is not subject to flooding.

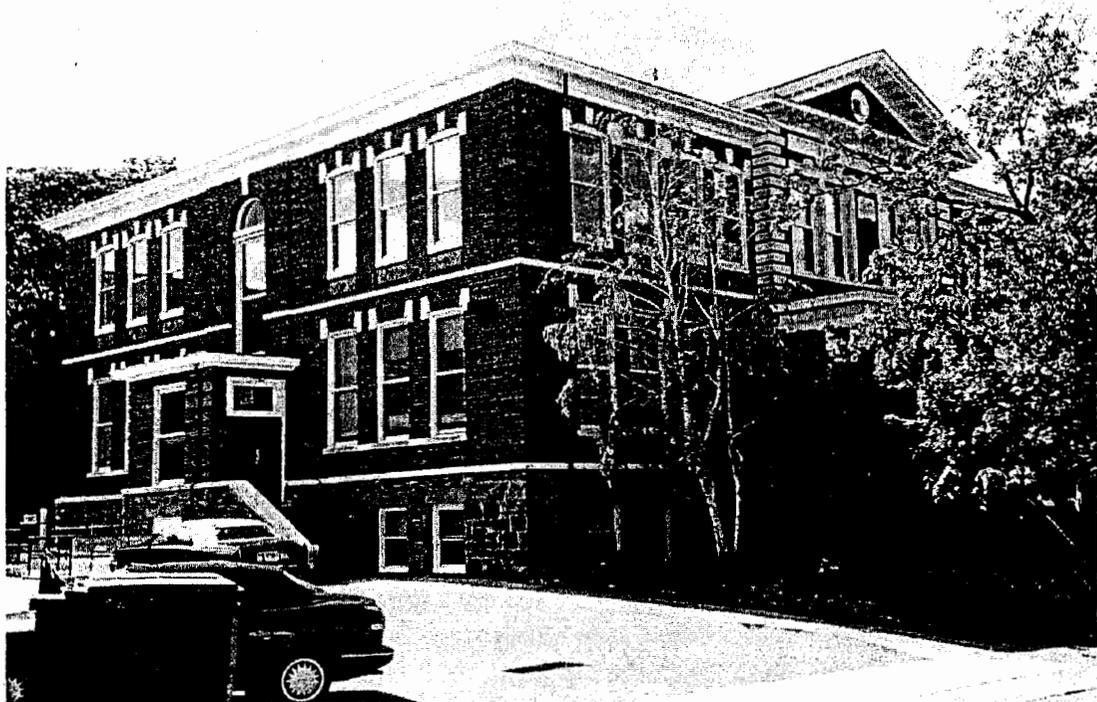
15 School Street.

- ◆ Current use is a functional downtown office space.
- ◆ Parking is located around the structure. Additional parking is located across the street.
- ◆ The parcel is not a thru-parcel to Post Road. Therefore, access must be maintained on both sides of the proposed facility

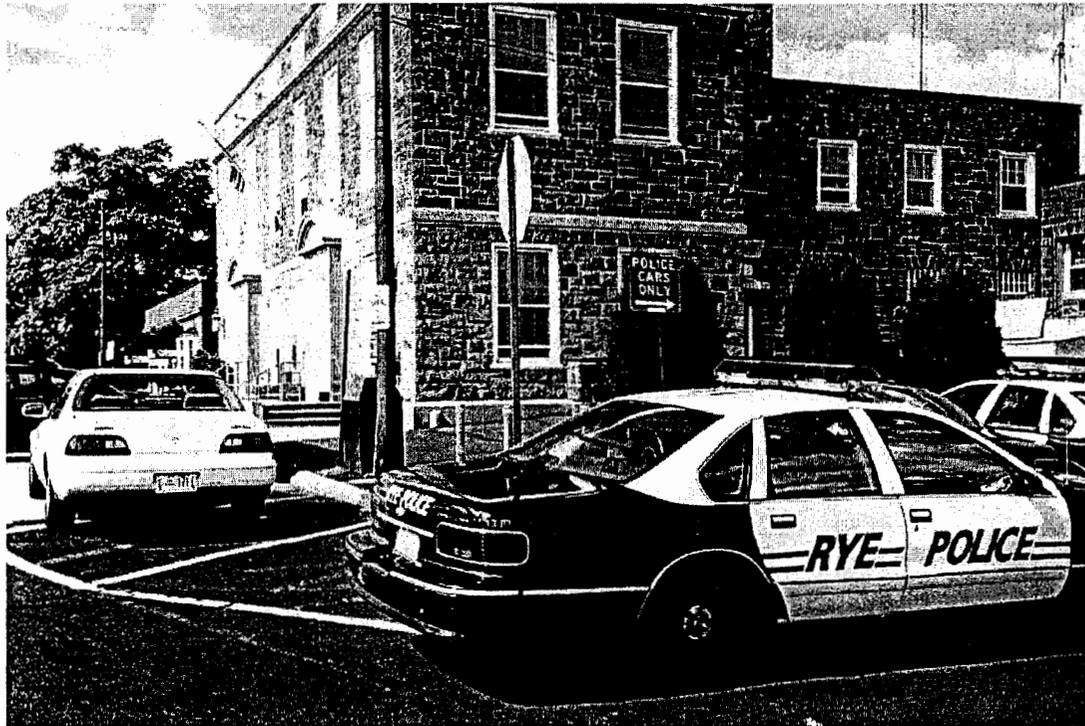
Existing Police Facility Location.

- ◆ Current facility is located on .22 acre site.
- ◆ Location is superb, but parking needs are not being met on the existing site.
- ◆ Selection of this site or Site 13 negates the sale of the property to offset any purchase/construction costs of the new facility.

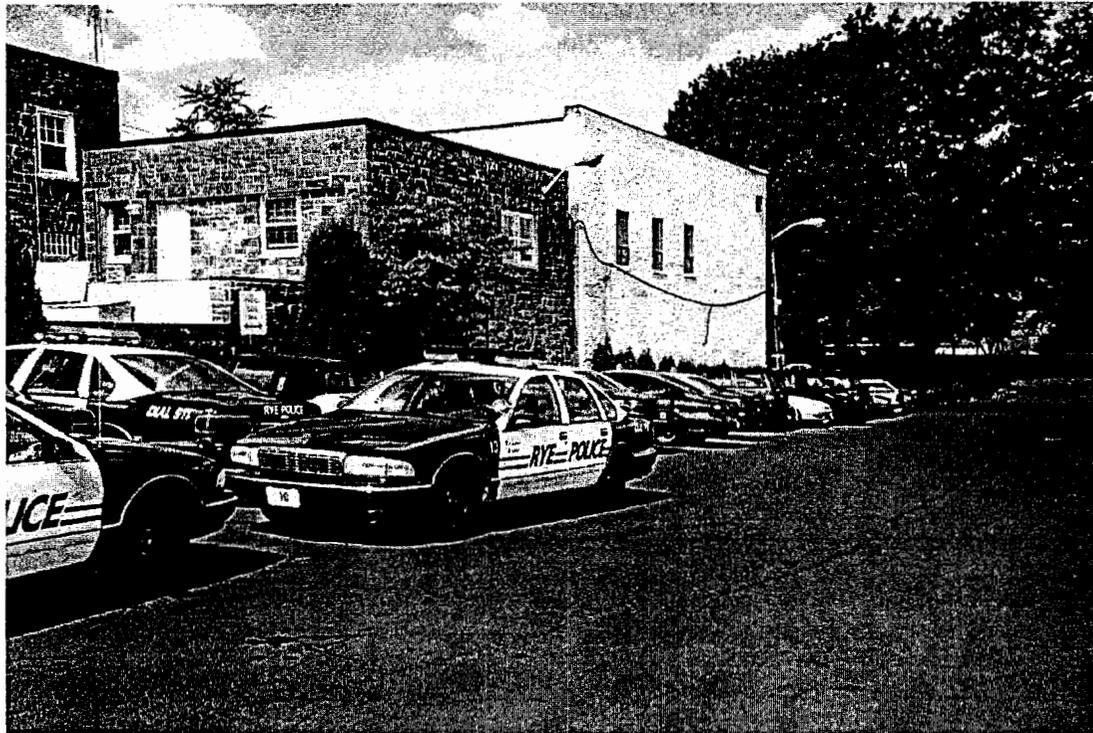
Existing police facility with adjacent warehouse.

Combined sites total .42 acres.
