CARLIN • SIMPSON & ASSOCIATES

Re: Report on Preliminary Geotechnical Evaluation for
Existing Retaining Wall #1
Scott & Elizabeth Pierpoint
2 Thistle Lane
Rye, NY (CSA Job #14-179)

EXISTING RETAINING WALL EVALUATION
PROPERTY # 1
2 THISTLE LANE
RYE, NEW YORK

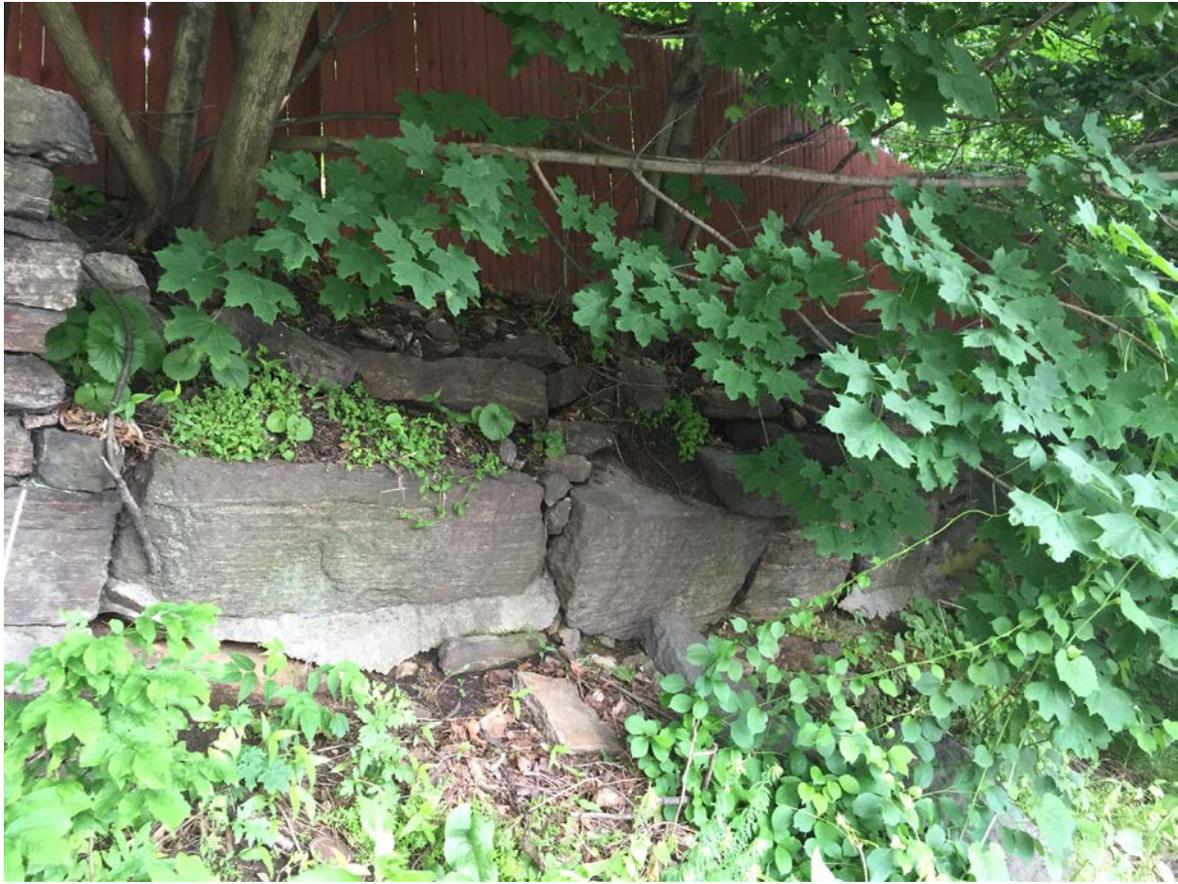
Photo No. 2

- The wall ranges in height from 2 to 6 feet.
- The wall consists of large and small rock blocks with pieces of mortar the rock block joints.
- It appears that sections of this wall have been re-built and the top of the wall has been extended or re-built with dry laid flat cinder blocks. (See photos 2, 3 & 4).
- The integrity of the wall varies where some areas appear stable while other areas show spalling rock blocks.
- This entire section above the wall is heavily vegetated and the wall was placed on an undulating bedrock outcrop.
- The width of the wall is unknown, however we estimate the thickness to be 2 to 3 feet.
- In general, the wall appears to be in poor condition with visible signs of distress.

In our professional opinion, portions of this wall are failing (specifically in the area of photos # 2 ,3 & 4) and the wall will need to be replaced or repaired.
