Flood Mitigation Study

Bowman Avenue Dam Site

City of Rye and the Village of Rye Brook

Presentation

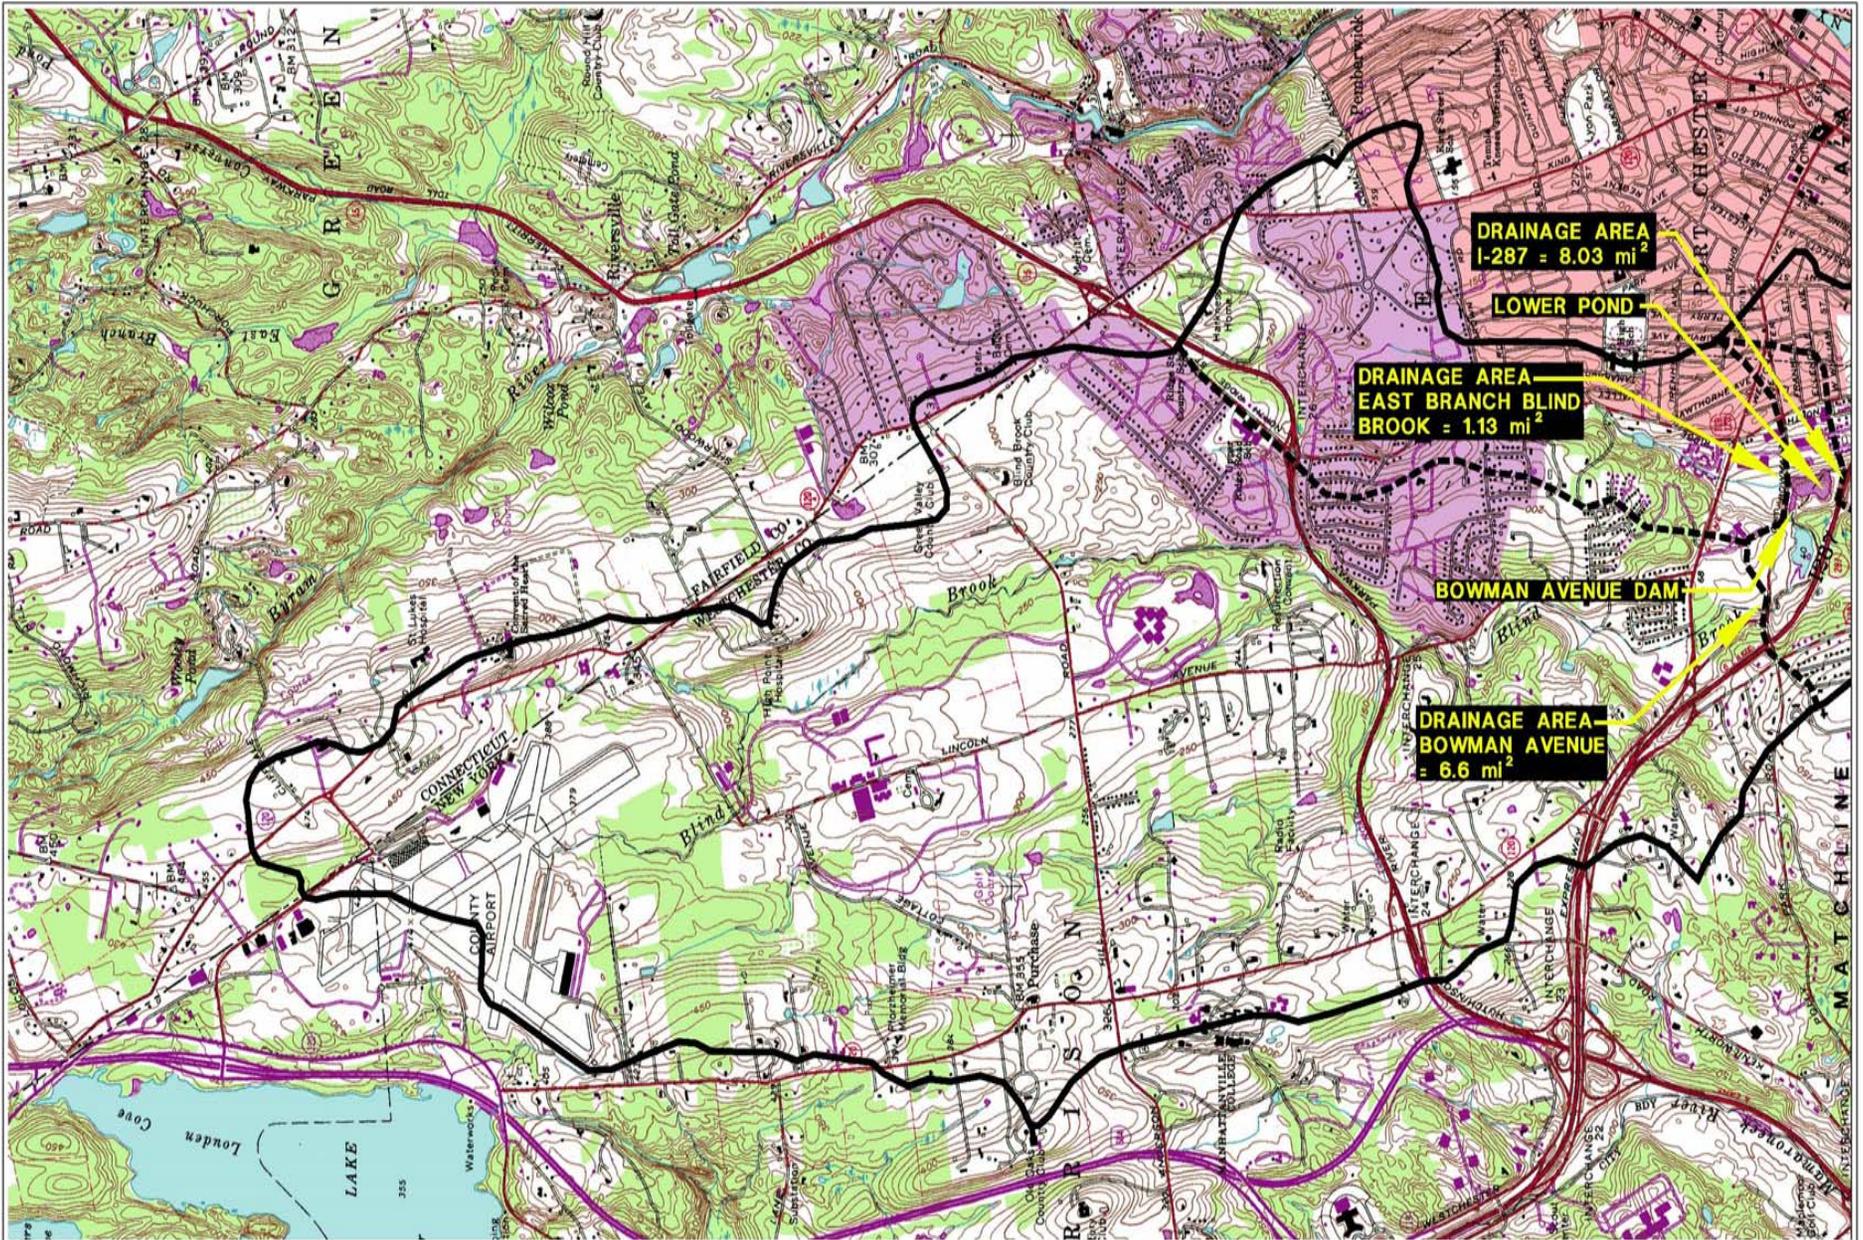
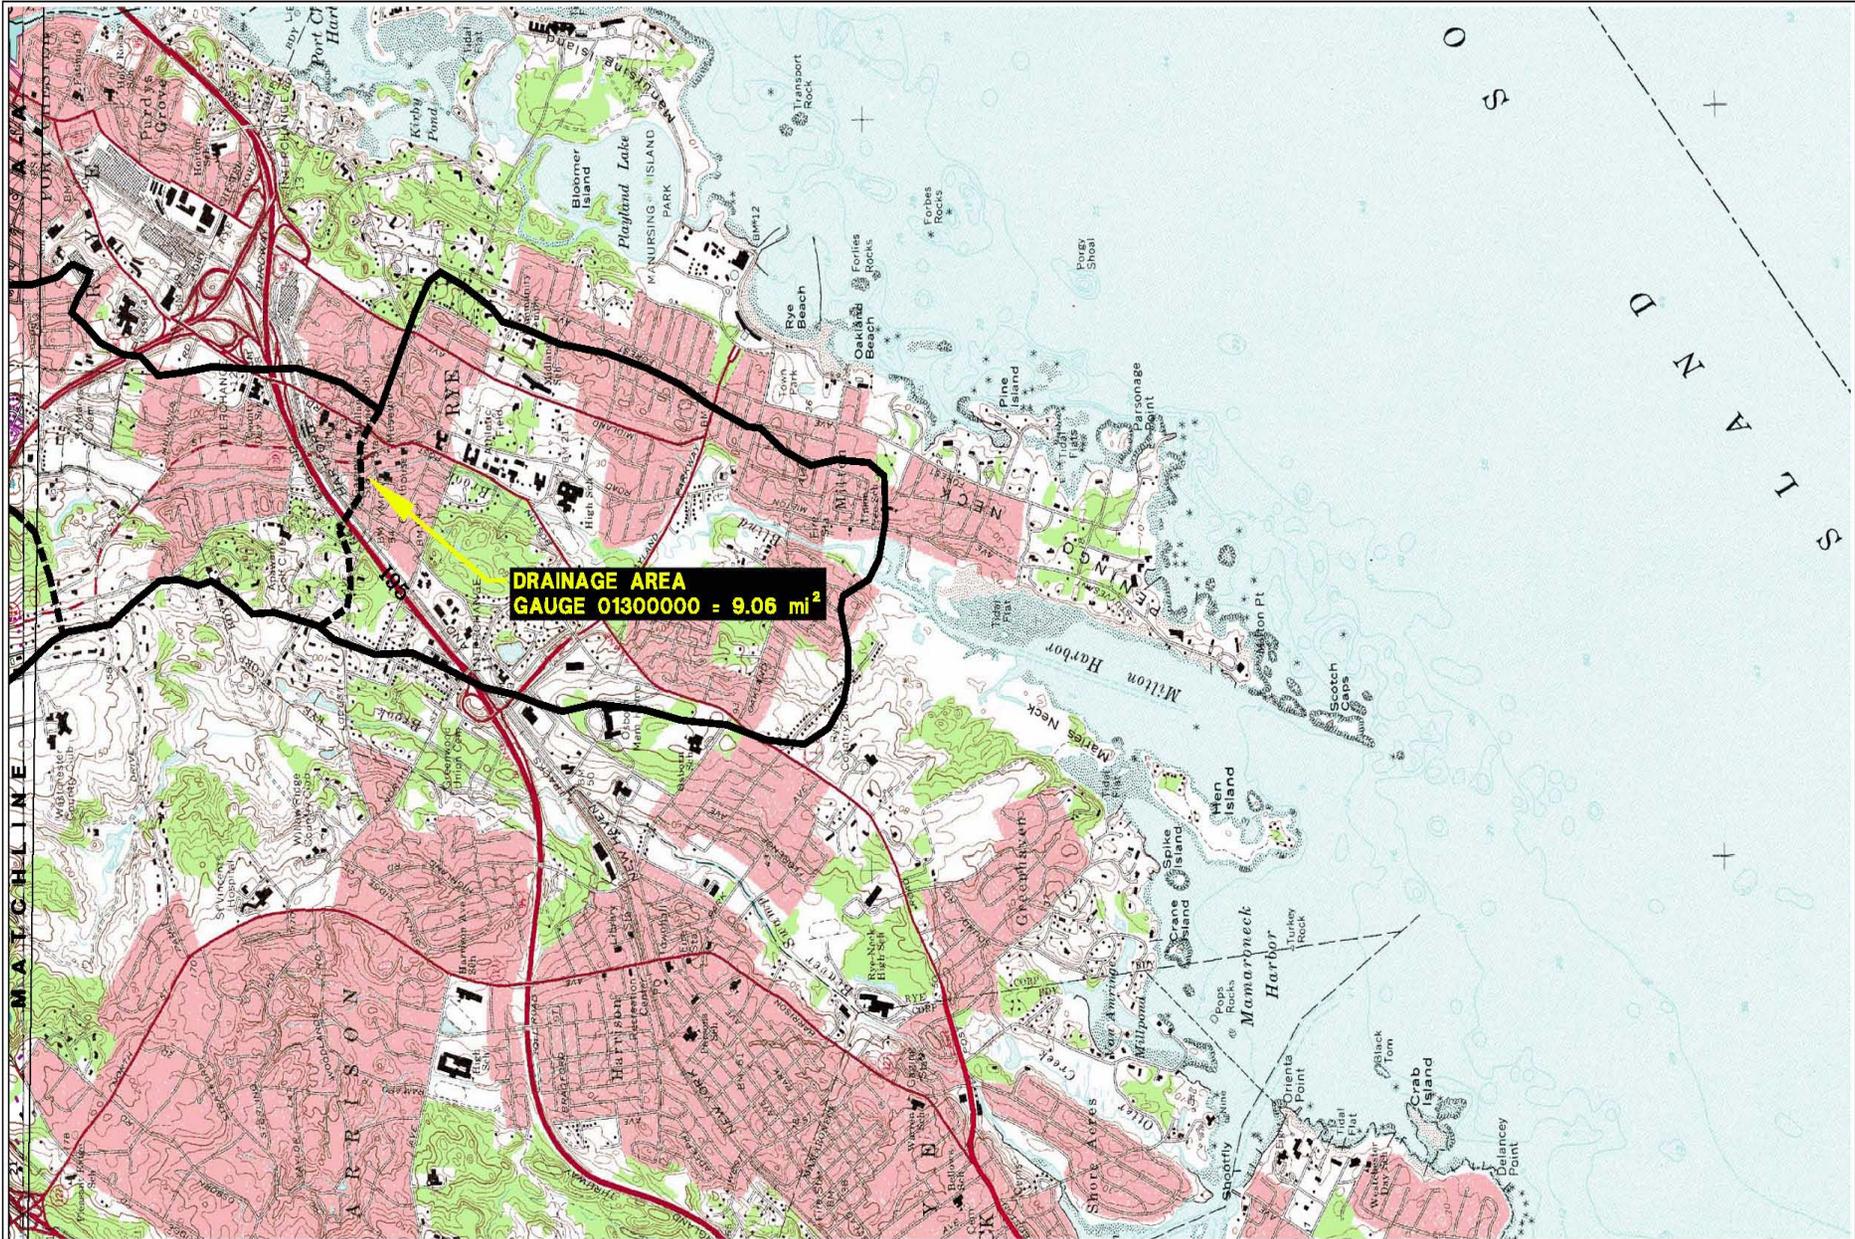
**DRAINAGE AREA
GAUGE 01300000 = 9.06 mi²**

- City of Rye, Villages of Harrison, Rye Brook and Port Chester, Town of Greenwich
- Suburban in upper and middle third, urbanized in lower third
- Low-medium density residential/commercial
- Watershed area is 9.6 sq.m. delineated at I-95
- Floodplain is wide compared to the channel

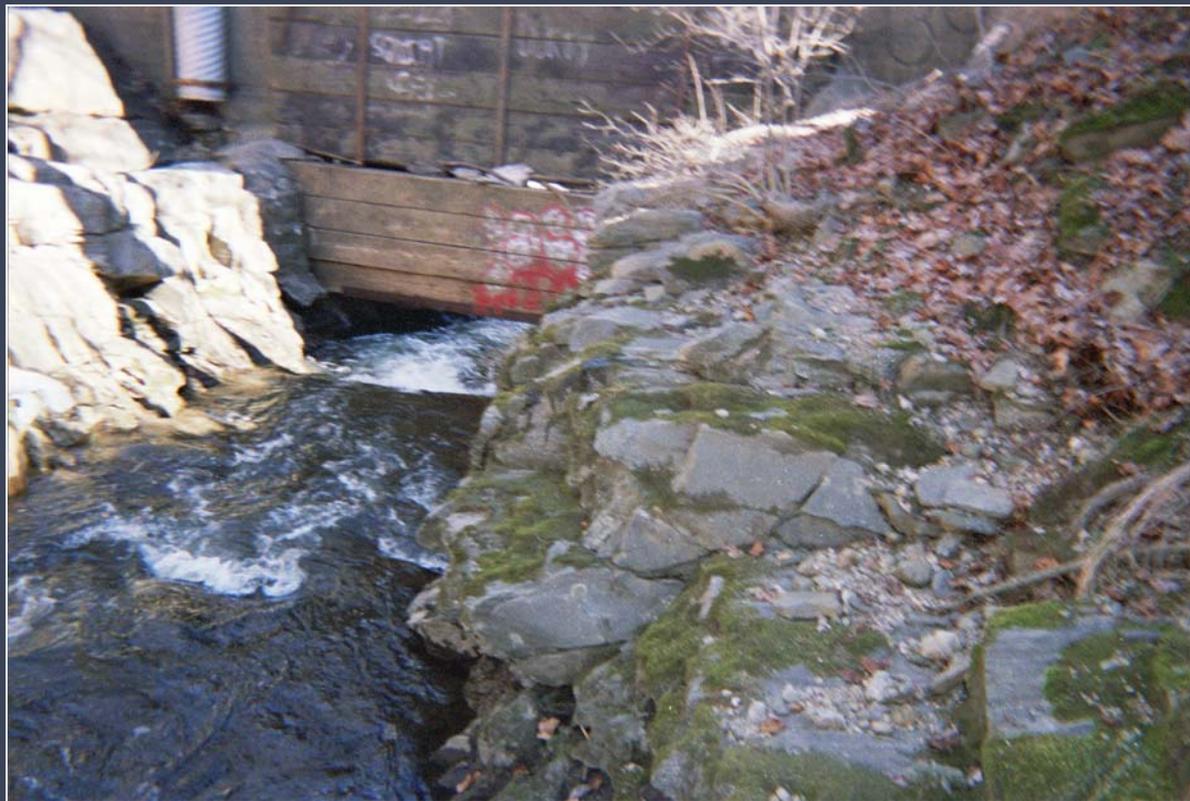
Bowman Avenue Dam Upstream Face

- Dam is only flood control facility on the Blind Brook
- Dam originally constructed in 1900's for ice production
- Reconstructed in 1941 after collapse
- Overall dimensions: 119 ft long x 19 ft high (max)
- Outlet dimensions: 15 ft wide x 2.5 ft high
- Upper pond heavily silted (145 acre-feet current capacity)

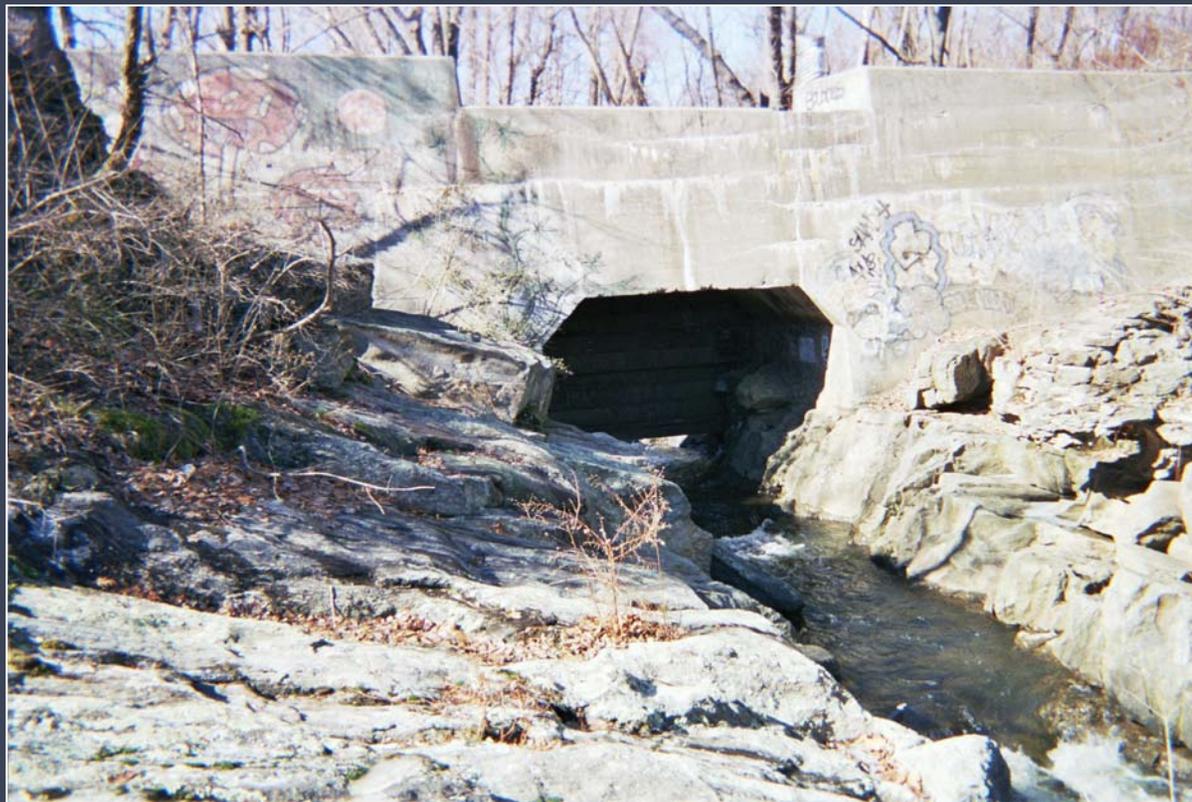
Bowman Avenue Dam Downstream Face

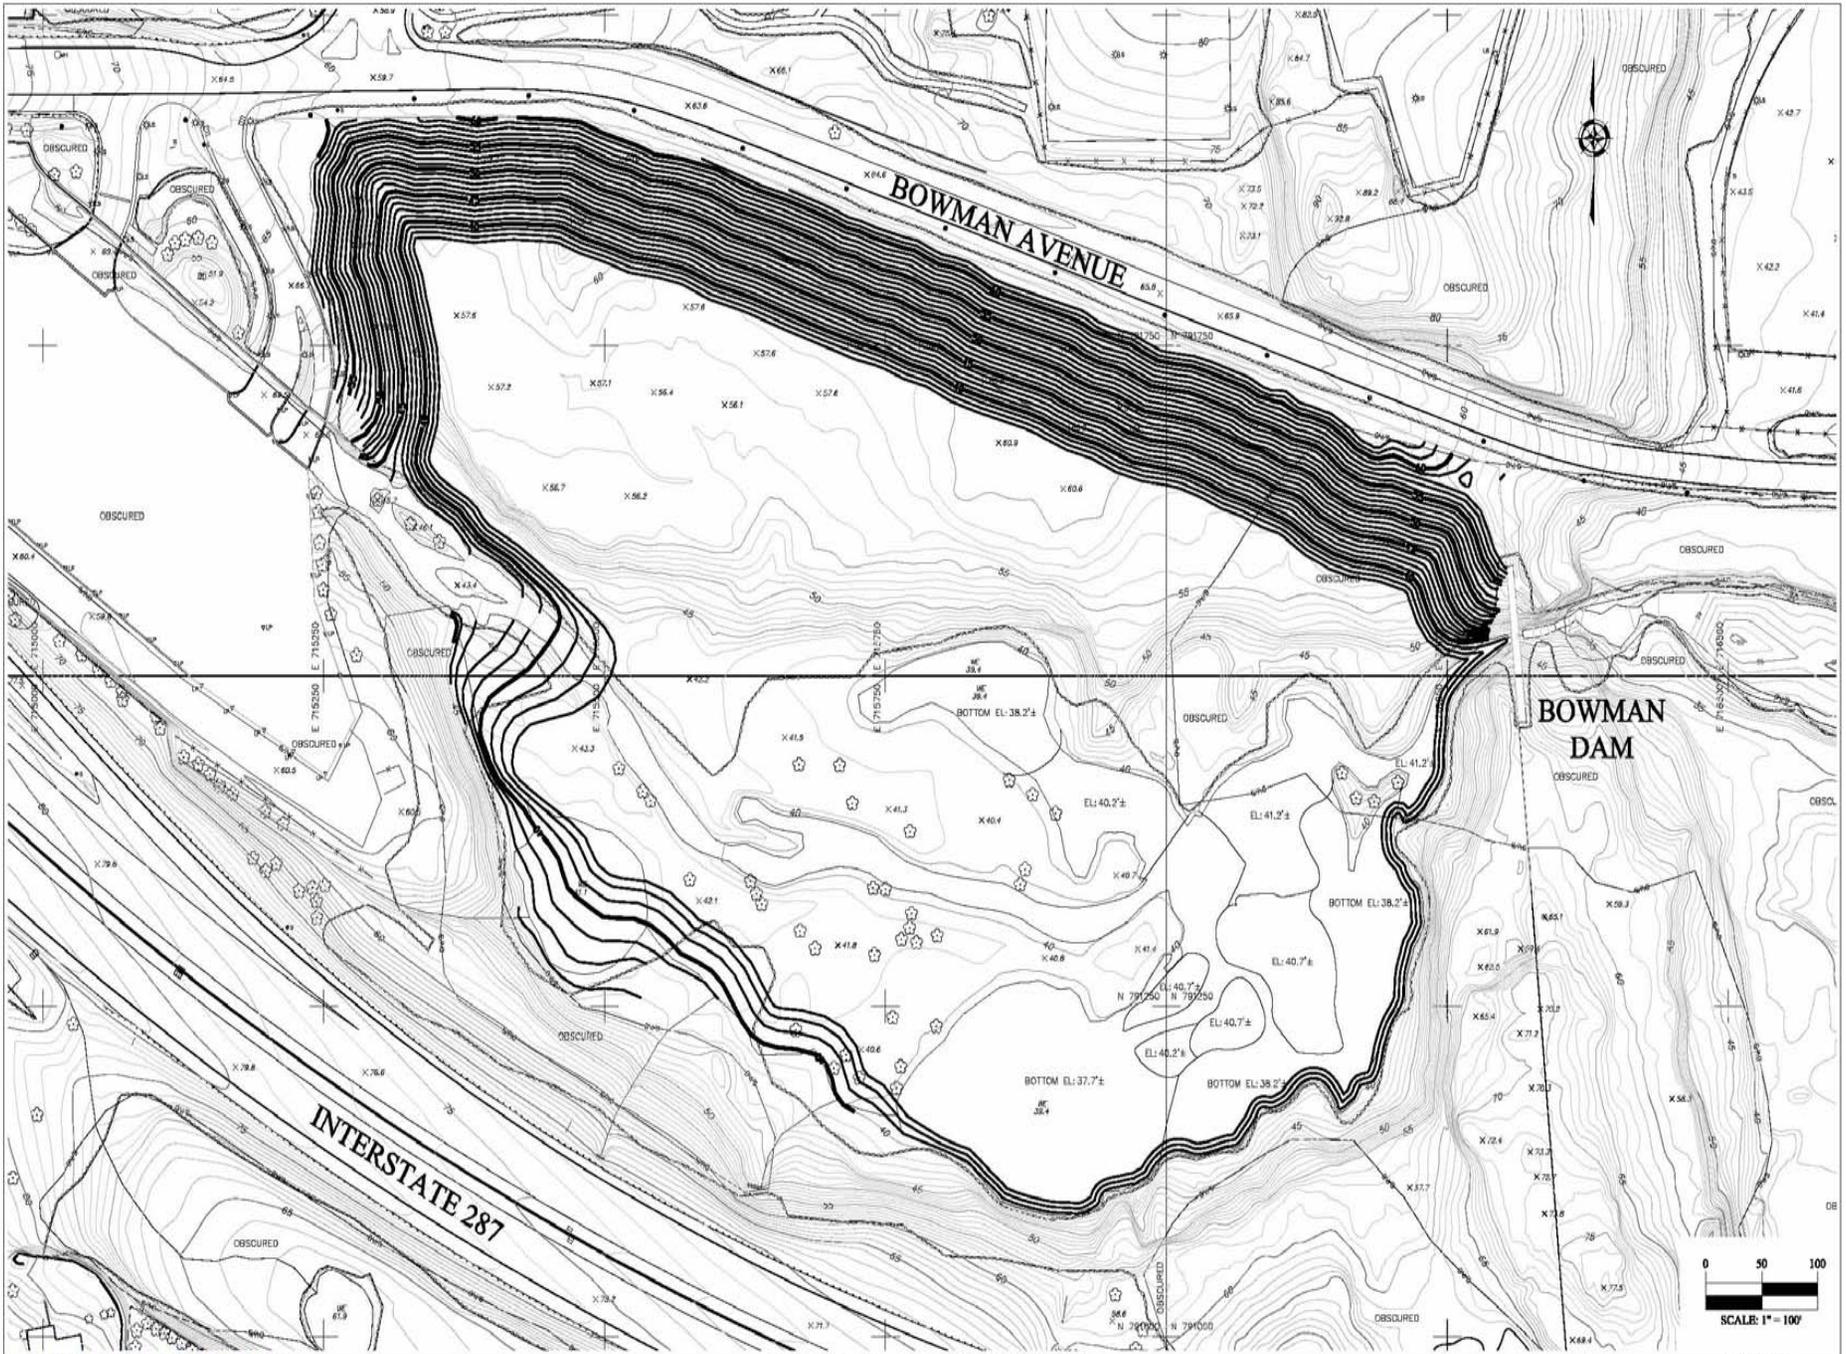
- a. Provide increased storage capacity
 - Enlargement through excavation
 - Silt removal through dredging
- b. Analyzed various limits of excavation with and without dredging
 - Alt. 1: Excavate pond to 1925 size w/o dredging (36,000 c.y.)
 - Alt. 2: Excavate pond to 1925 size with 2 feet of dredging (53,000 c.y.)
 - Alt. 3: Maximize size of pond w/o dredging (160,000 c.y.)
 - Alt. 4: Maximize size of pond with dredging (190,000 c.y.)
- c. Preliminarily estimated impact due to rock and contaminated soils

- Meaningful flow reductions were achieved
- Increase storage from 145 to 245 acre-feet

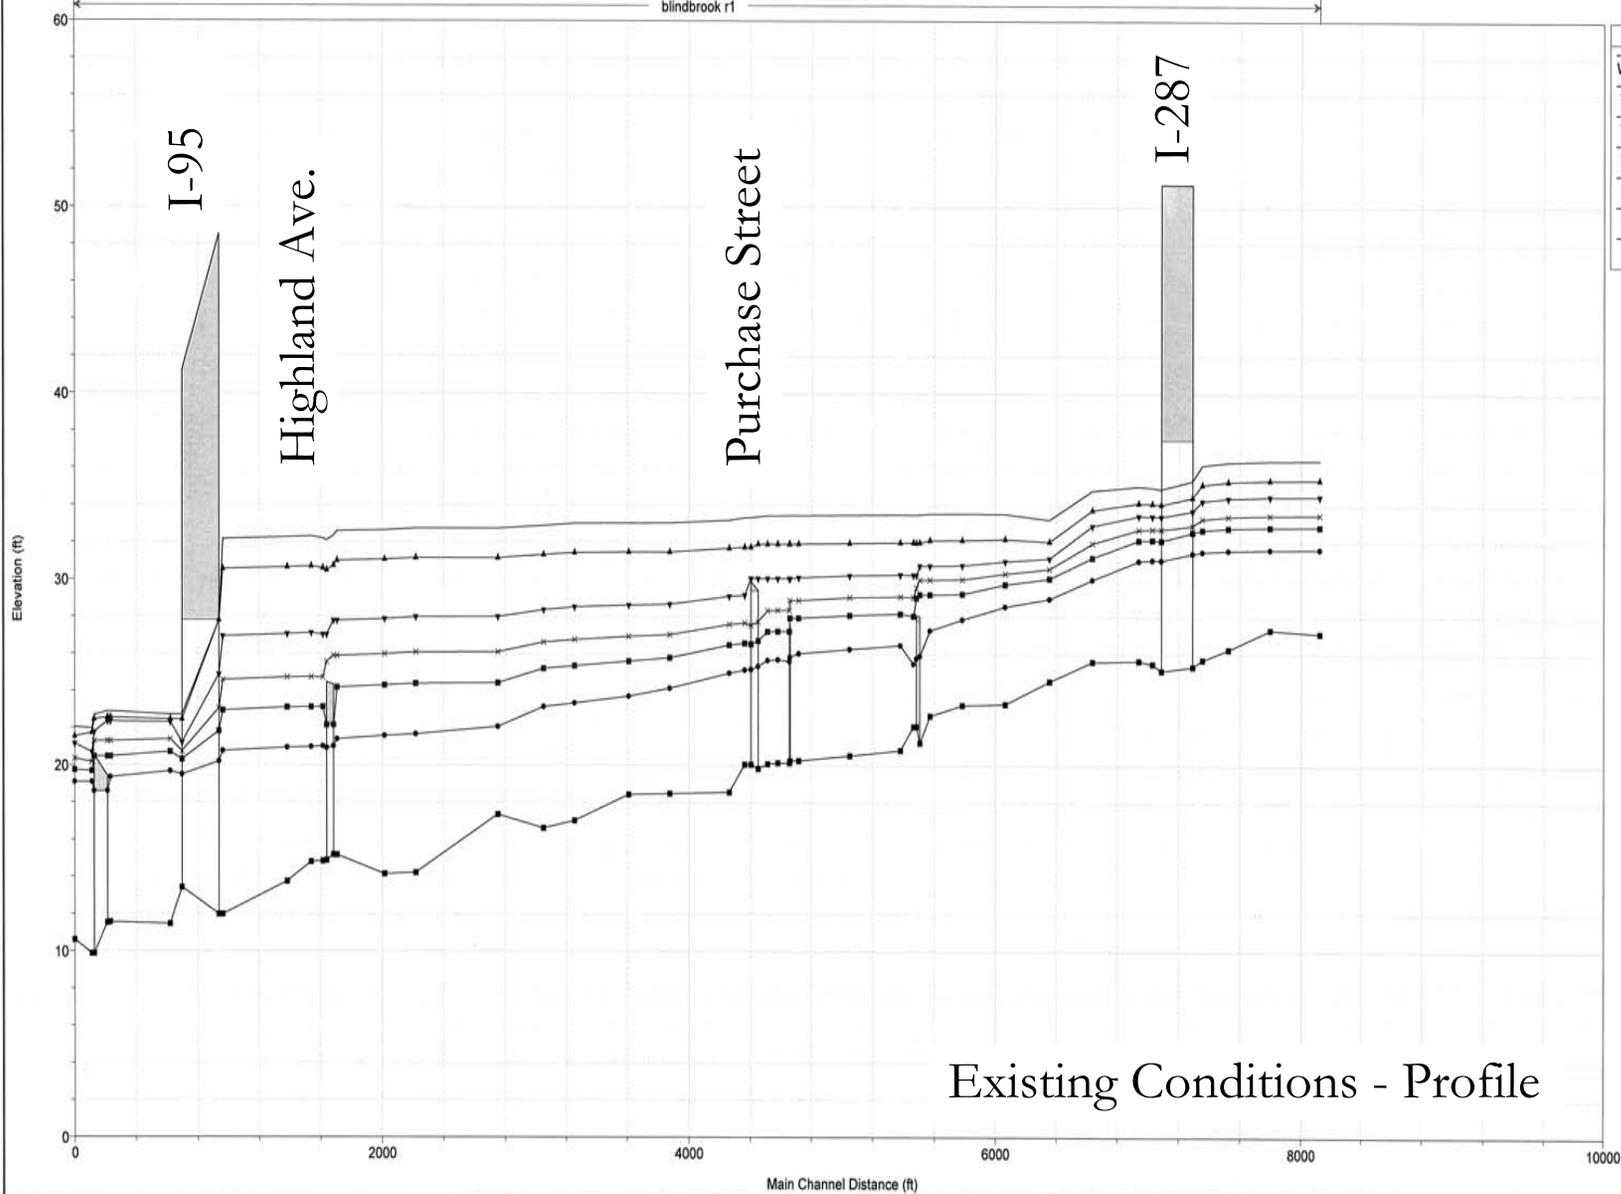
Existing Conditions - Profile

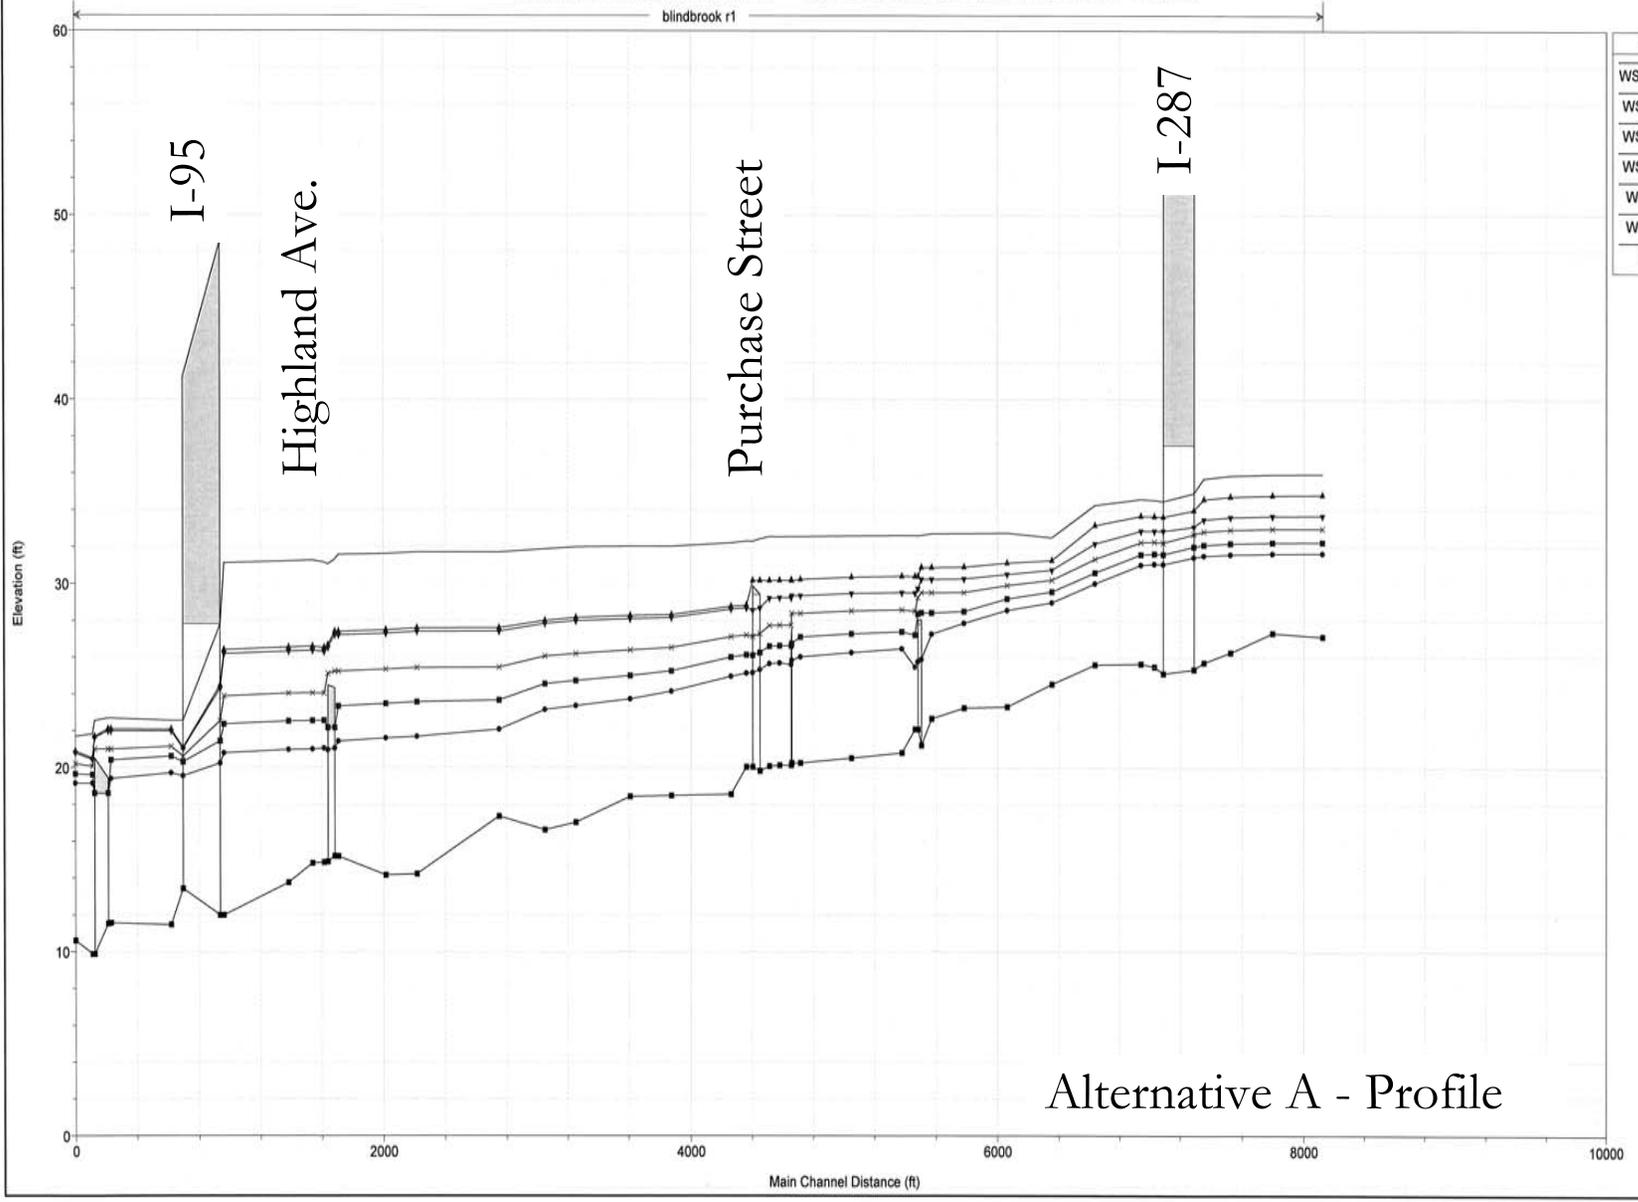
Alternative A - Optimizing Outlet Opening

Alternative A - Profile

ALTERNATIVE A	Orifice Size	Water Surface Elevation (ft-NAVD)		
		Existing Cond.	Proposed Cond.	Difference
2-Year Storm	20.2			
D/S I-287		31.07	31.07	0.00
Purchase Street		25.65	25.65	0.00
Highland Road		21.41	21.43	0.02
U/S I-95		20.77	20.80	0.03
5-Year Storm	45.6			
D/S I-287		32.15	31.62	-0.53
Purchase Street		27.20	26.61	-0.59
Highland Road		24.19	23.35	-0.84
U/S I-95		22.95	22.36	-0.59
10-Year Storm	72.1			
D/S I-287		32.73	32.27	-0.46
Purchase Street		28.33	27.73	-0.60
Highland Road		25.88	25.24	-0.64
U/S I-95		24.59	23.89	-0.70
25-Year Storm	105.6			
D/S I-287		33.44	32.87	-0.57
Purchase Street		30.06	29.21	-0.85
Highland Road		27.78	27.20	-0.58
U/S I-95		26.93	26.19	-0.74
50-Year Storm	139.1			
D/S I-287		34.11	33.66	-0.45
Purchase Street		31.91	30.18	-1.73
Highland Road		31.01	27.39	-3.62
U/S I-95		30.56	26.41	-4.15
100-Year Storm	139.1			
D/S I-287		34.97	34.54	-0.43
Purchase Street		33.44	32.55	-0.89
Highland Road		32.60	31.57	-1.03

U/S I-95		32.17	31.12	-1.05

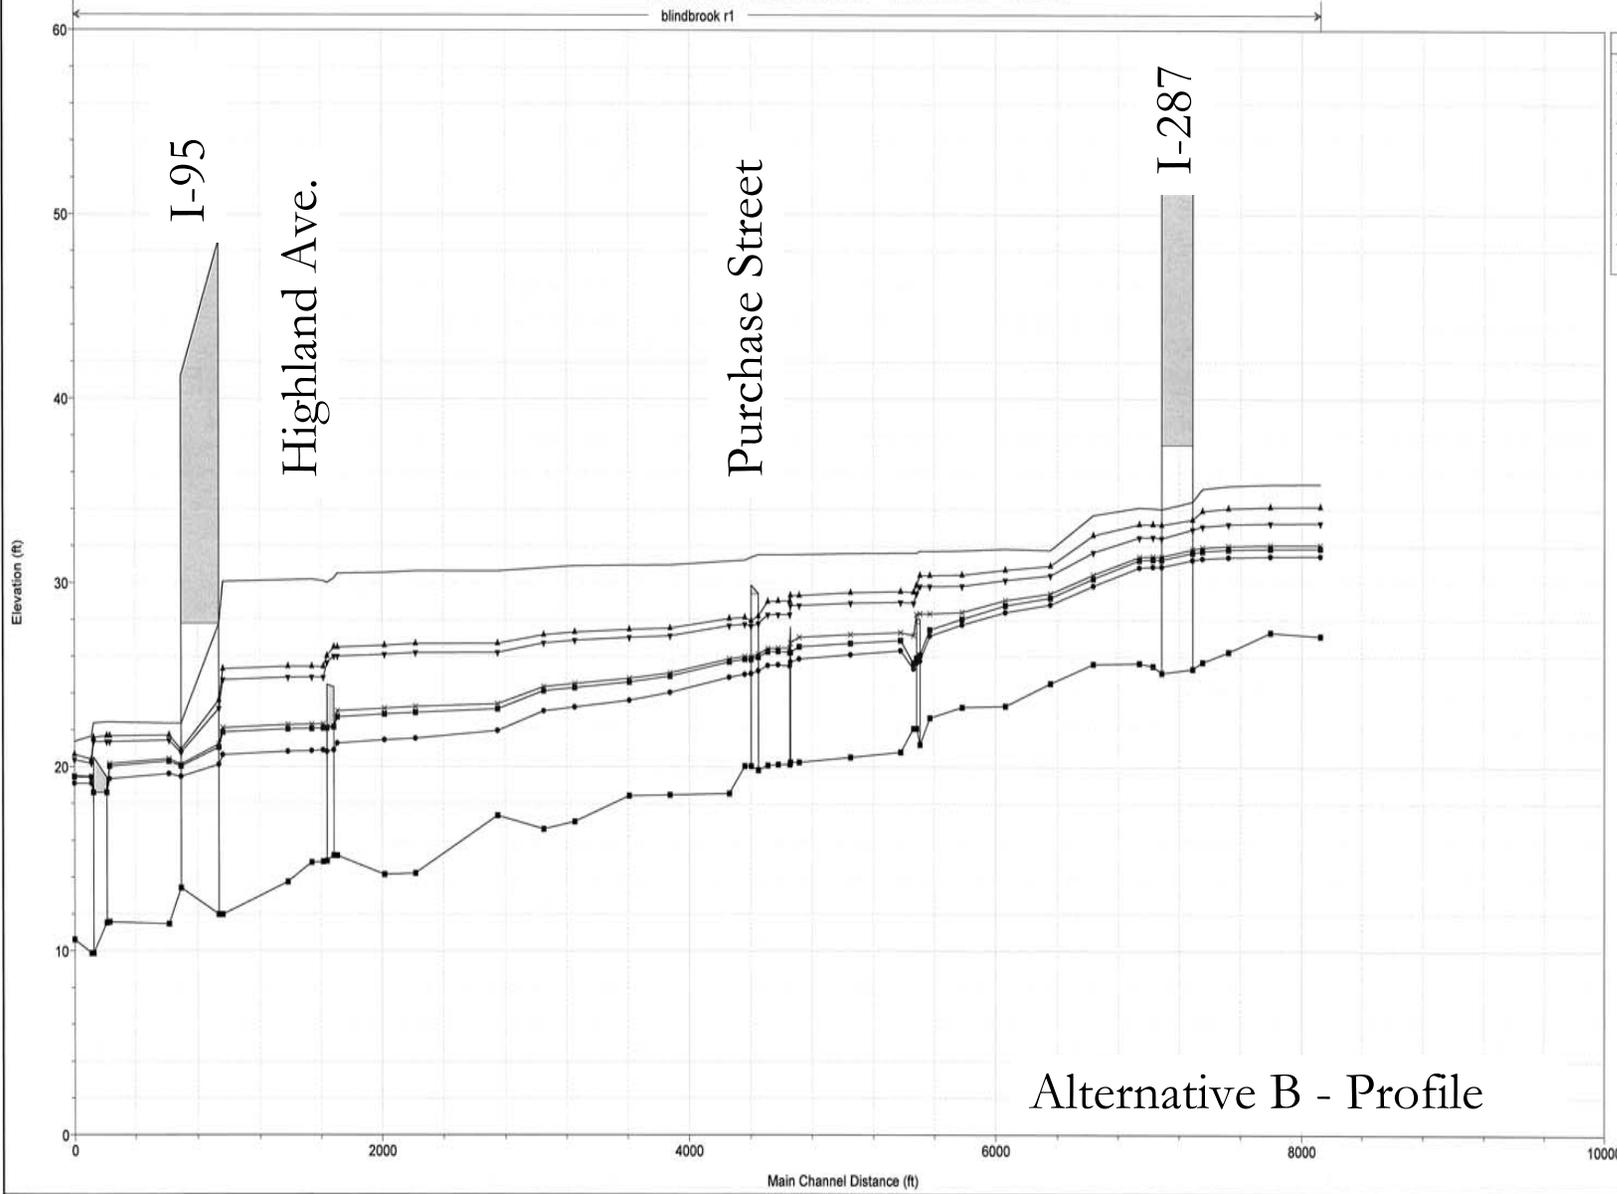
Alternative B –
Optimize Outlet
with maximizing
Upper Pond Area

Alternative B - Profile

ALTERNATIVE B	Orifice Size	Water Surface Elevation (ft.-NAVD)		
		Existing Cond.	Proposed Cond.	Difference
2-Year Storm	20.2			
D/S I-287		31.07	30.90	-0.17
Purchase Street		25.65	25.52	-0.13
Highland Road		21.41	21.29	-0.12
U/S I-95		20.77	20.66	-0.11
5-Year Storm	45.6			
D/S I-287		32.15	31.29	-0.86
Purchase Street		27.20	26.27	-0.93
Highland Road		24.19	22.72	-1.47
U/S I-95		22.95	21.89	-1.06
10-Year Storm	45.6			
D/S I-287		32.73	31.47	-1.26
Purchase Street		28.33	26.45	-1.88
Highland Road		25.88	23.04	-2.84
U/S I-95		24.59	22.12	-2.47
25-Year Storm	72.1			
D/S I-287		33.44	32.51	-0.93
Purchase Street		30.06	28.28	-1.78
Highland Road		27.78	26.01	-1.77
U/S I-95		26.93	24.73	-2.20
50-Year Storm	139.1			
D/S I-287		34.11	33.20	-0.91
Purchase Street		31.91	29.00	-2.91
Highland Road		31.01	26.51	-4.50
U/S I-95		30.56	25.32	-5.24
100-Year Storm	139.1			
D/S I-287		34.97	34.08	-0.89
Purchase Street		33.44	31.54	-1.90
Highland Road		32.60	30.52	-2.08

U/S I-95		32.17	30.07	-2.10

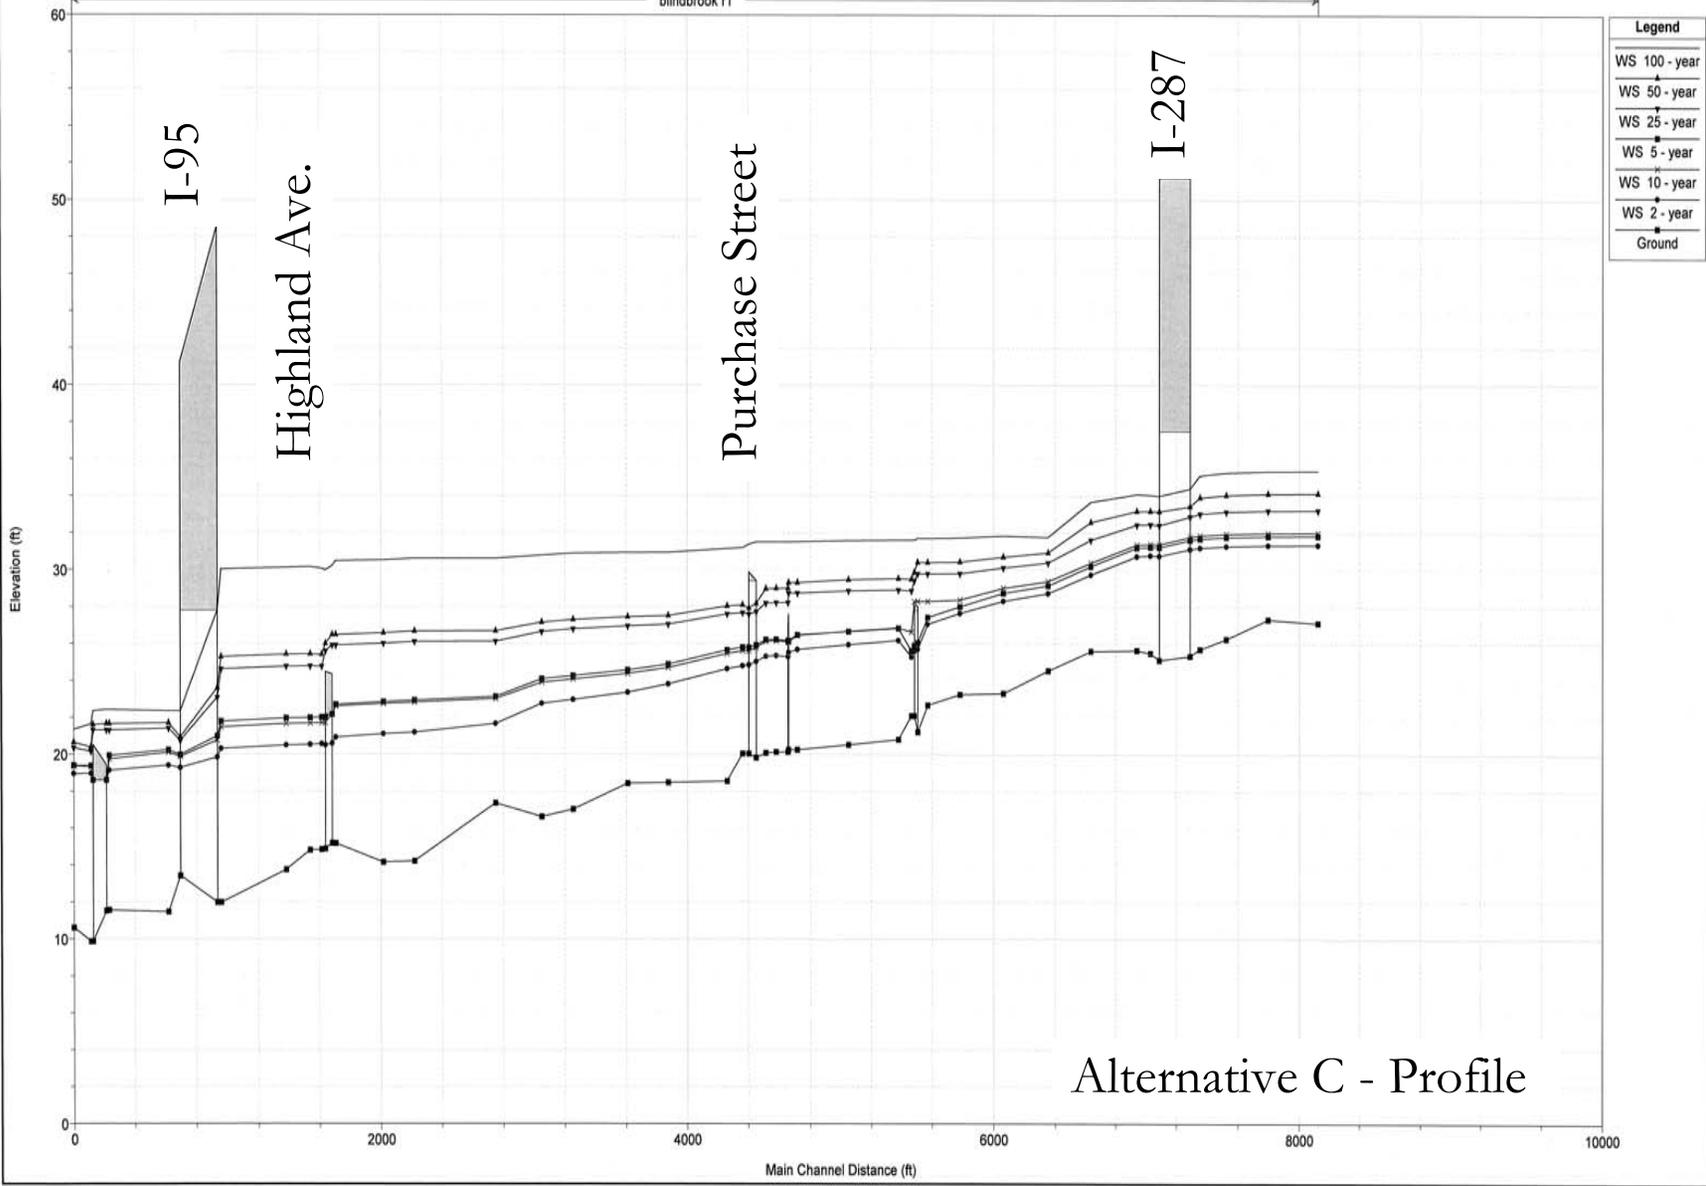
Alternative C –
Optimize Outlet with
maximizing Upper
Pond Area and
dredging

Alternative C - Profile

ALTERNATIVE C	Orifice Size	Water Surface Elevation (ft-NAVD)		
		Existing Cond.	Proposed Cond.	Difference
2-Year Storm	20.2			
D/S I-287		31.07	30.79	-0.28
Purchase Street		25.65	25.32	-0.33
Highland Road		21.41	20.93	-0.48
U/S I-95		20.77	20.32	-0.45
5-Year Storm	45.6			
D/S I-287		32.15	31.25	-0.90
Purchase Street		27.20	26.22	-0.98
Highland Road		24.19	22.70	-1.49
U/S I-95		22.95	21.79	-1.16
10-Year Storm	45.6			
D/S I-287		32.73	31.41	-1.32
Purchase Street		28.33	26.14	-2.19
Highland Road		25.88	22.62	-3.26
U/S I-95		24.59	21.48	-3.11
25-Year Storm	72.1			
D/S I-287		33.44	32.47	-0.97
Purchase Street		30.06	28.20	-1.86
Highland Road		27.78	25.92	-1.86
U/S I-95		26.93	24.62	-2.31
50-Year Storm	139.1			
D/S I-287		34.11	33.19	-0.92
Purchase Street		31.91	28.98	-2.93
Highland Road		31.01	26.48	-4.53
U/S I-95		30.56	25.29	-5.27
100-Year Storm	139.1			
D/S I-287		34.97	34.06	-0.91
Purchase Street		33.44	31.51	-1.93
Highland Road		32.60	30.48	-2.12

U/S I-95		32.17	30.04	-2.13

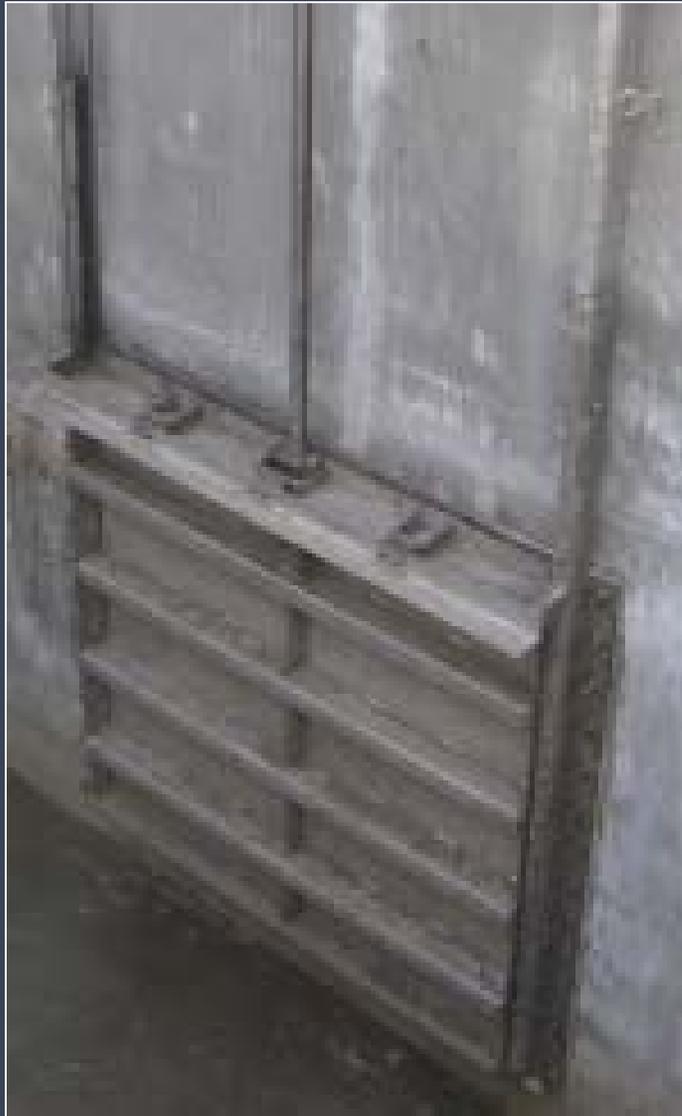
Typical sluice gate

- Install automated sluice gate system at Bowman Avenue Dam
- Cost-effective solution: \$1 - \$2 million (budgetary construction cost)
- Dynamic solution: system may be adjusted based on future needs
- Secure funding for sluice gate design and construction (HMGP application)
